**DEPARTMENT OF TRANSPORTATION**

Contract #: 04-0120F4Cty: SF/ALA Rte: 80 PM: 13.2/13.9File #: 69.28**WELDING INSPECTION REPORT****Resident Engineer:** Pursell, Gary**Address:** 333 Burma Road**City:** Oakland, CA 94607**Report No:** WIR-004171**Date Inspected:** 14-Sep-2008**Project Name:** SAS Superstructure**OSM Arrival Time:** 700**Prime Contractor:** American Bridge/Fluor Enterprises, a JV**OSM Departure Time:** 1700**Contractor:** Zhenhua Port Machinery Company, Ltd (ZPMC), Changxing Island **Location:** Shanghai, China**CWI Name:** Sun Wei**CWI Present:** Yes No**Inspected CWI report:** Yes No N/A**Rod Oven in Use:** Yes No N/A**Electrode to specification:** Yes No N/A**Weld Procedures Followed:** Yes No N/A**Qualified Welders:** Yes No N/A**Verified Joint Fit-up:** Yes No N/A**Approved Drawings:** Yes No N/A**Approved WPS:** Yes No N/A**Delayed / Cancelled:** Yes No N/A**Bridge No:** 34-0006**Component:** OBG**Summary of Items Observed:**

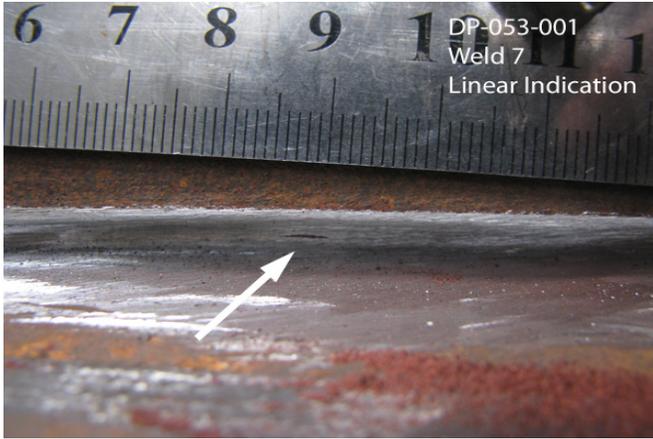
The Quality Assurance Inspector observed ZPMC continuing to repair cracks in the tack weld areas of numerous deck panels. Two ABF representatives were present tracking the locations and witnessing the repairs. ZPMC was performing the weld repairs to Deck Panels DP-051-001, DP-050-001, DP-074-001, DP-075-001, DP-053-001 and DP-054-001. The Quality Assurance Inspector tracked the locations and the status of the repairs and recorded the data in an onsite log for future review. In addition the Quality Assurance Inspector witnessed ZPMC in the process of excavating a number of deck panels identified as DP-55-001, DP-056-001, DP-044-001, and DP-042-001. The Quality Assurance Inspector performed magnetic particle verification to the repairs after the tacks were excavated; the root pass was deposited and ground. No relevant indications were observed.

For informational purposes only ZPMC performed magnetic particle testing to the initial excavation. The Quality Assurance Inspector observed on numerous excavations a linear indication indicative of a crack at the exact location where the Quality Assurance Ultrasonic technicians marked the area as cracked below is digital photograph illustrating one of the indications.
