**DEPARTMENT OF TRANSPORTATION**

Contract #: 04-0120F4Cty: SF/ALA Rte: 80 PM: 13.2/13.9File #: 69.28**WELDING INSPECTION REPORT****Resident Engineer:** Pursell, Gary**Address:** 333 Burma Road**City:** Oakland, CA 94607**Report No:** WIR-004175**Date Inspected:** 22-Sep-2008**Project Name:** SAS Superstructure**OSM Arrival Time:** 700**Prime Contractor:** American Bridge/Fluor Enterprises, a JV**OSM Departure Time:** 1700**Contractor:** Zhenhua Port Machinery Company, Ltd (ZPMC), Changxing Island **Location:** Shanghai, China**CWI Name:** Sun Wei**CWI Present:** Yes No**Inspected CWI report:** Yes No N/A**Rod Oven in Use:** Yes No N/A**Electrode to specification:** Yes No N/A**Weld Procedures Followed:** Yes No N/A**Qualified Welders:** Yes No N/A**Verified Joint Fit-up:** Yes No N/A**Approved Drawings:** Yes No N/A**Approved WPS:** Yes No N/A**Delayed / Cancelled:** Yes No N/A**Bridge No:** 34-0006**Component:** OBG**Summary of Items Observed:**

**Tower Strut Partial Mock-up**

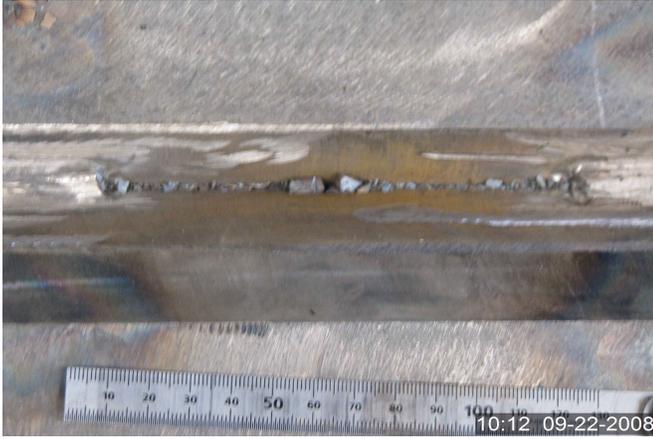
The Quality Assurance Inspector observed ZPMC in the process of performing in process welding of the 89M Strut Partial Mock-up. ZPMC was utilizing the shielded metal arc welding process to deposit the root pass of the flanges and web complete joint penetration splices. The Quality Assurance Inspector informed an ABF Representative of a small amount of rust on the bevel faces of the welds. The ABF representative relayed he would have ZPMC remove the rust prior to any further welding. Below is a digital photograph illustrating the rust.
