DEPARTMENT OF TRANSPORTATION

Contract #: 04-0120F4Cty: SF/ALA Rte: 80 PM: 13.2/13.9File #: 69.28**WELDING INSPECTION REPORT****Resident Engineer:** Pursell, Gary**Address:** 333 Burma Road**City:** Oakland, CA 94607**Report No:** WIR-004177**Date Inspected:** 27-Sep-2008**Project Name:** SAS Superstructure**OSM Arrival Time:** 700**Prime Contractor:** American Bridge/Fluor Enterprises, a JV**OSM Departure Time:** 1700**Contractor:** Zhenhua Port Machinery Company, Ltd (ZPMC), Changxing Island **Location:** Shanghai, China**CWI Name:** Sun Wei**CWI Present:** Yes No**Inspected CWI report:** Yes No N/A**Rod Oven in Use:** Yes No N/A**Electrode to specification:** Yes No N/A**Weld Procedures Followed:** Yes No N/A**Qualified Welders:** Yes No N/A**Verified Joint Fit-up:** Yes No N/A**Approved Drawings:** Yes No N/A**Approved WPS:** Yes No N/A**Delayed / Cancelled:** Yes No N/A**Bridge No:** 34-0006**Component:** Tower**Summary of Items Observed:**

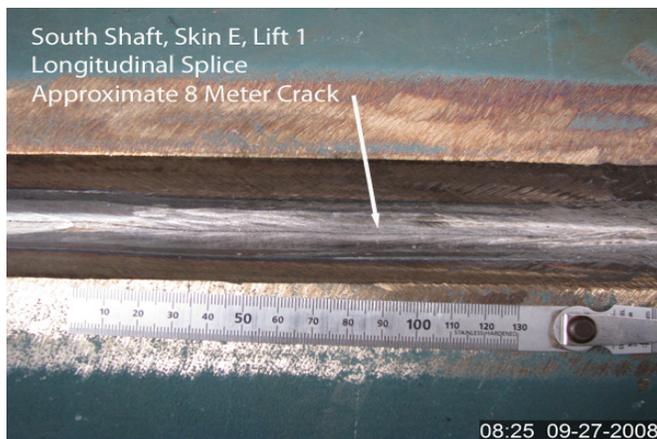
South Shaft, Skin E, Lift 2

The Quality Assurance Inspector was informed by ZPMC Quality Control that a root pass in Skin Plate E, South Shaft, lift 2, Longitudinal Splice appears to have a crack like indication observed visually. The Quality Assurance Inspector observed the crack to be approximately eight meters in length. It was relayed ZPMC welded three passes on what will be the interior of the skin plate, flipped the part and performed back gouging operations utilizing the air carbon arc gouging process. After grinding to bright metal ZPMC observed the crack. The Quality Assurance Inspector suggested performing magnetic particle testing prior to repairing the crack. ZPMC relayed it was not necessary and would repair the crack by utilizing the air carbon arc process and grinders. The Quality Assurance Inspector marked the areas where the cracks were observed on the skin plate in order to perform Ultrasonic verification once the weld is completed. Below is a digital photograph of the crack.
