DEPARTMENT OF TRANSPORTATION

Contract #: 04-0120F4Cty: SF/ALA Rte: 80 PM: 13.2/13.9File #: 69.28**WELDING INSPECTION REPORT****Resident Engineer:** Pursell, Gary**Address:** 333 Burma Road**City:** Oakland, CA 94607**Report No:** WIR-004235**Date Inspected:** 07-Oct-2008**Project Name:** SAS Superstructure**OSM Arrival Time:** 1330**Prime Contractor:** American Bridge/Fluor Enterprises, a JV**OSM Departure Time:** 2230**Contractor:** Zhenhua Port Machinery Company, Ltd (ZPMC), Changxing Island **Location:** Shanghai, China

Heavy Bay 1

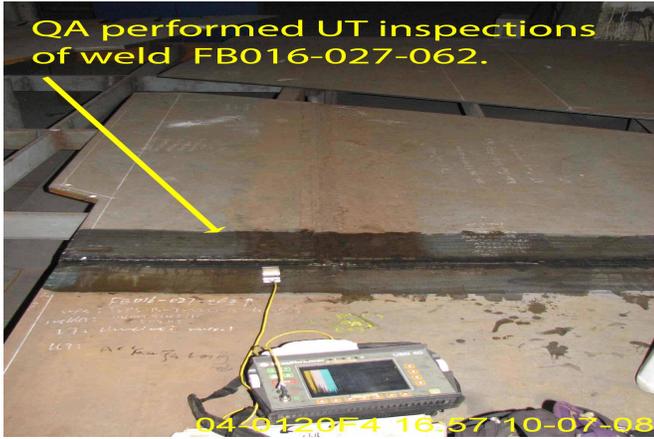
QA Inspector Mr. Eric Prue and this QA Inspector performed random visual inspections of SSDI Skin "A" stiffener to skin plate welds between elevation 0 and 38 meters. This Inspector identified five areas that require rework and Mr. Prue identified seven areas that require rework. The welds between elevation 38 meters and 48.6 meters will be inspected by the third shift QA Inspectors. ABF representative Mr. Don Walton informed the QA Inspector that several of the weld relief areas at approximately 30 meter elevation require additional welding which will take place tomorrow.
