**DEPARTMENT OF TRANSPORTATION**

Contract #: 04-0120F4Cty: SF/ALA Rte: 80 PM: 13.2/13.9File #: 69.28**WELDING INSPECTION REPORT****Resident Engineer:** Pursell, Gary**Address:** 333 Burma Road**City:** Oakland, CA 94607**Report No:** WIR-004276**Date Inspected:** 18-Oct-2008**Project Name:** SAS Superstructure**OSM Arrival Time:** 700**Prime Contractor:** American Bridge/Fluor Enterprises, a JV**OSM Departure Time:** 1700**Contractor:** Zhenhua Port Machinery Company, Ltd (ZPMC), Changxing Island **Location:** Shanghai, China**CWI Name:** Sun Wei**CWI Present:** Yes No**Inspected CWI report:** Yes No N/A**Rod Oven in Use:** Yes No N/A**Electrode to specification:** Yes No N/A**Weld Procedures Followed:** Yes No N/A**Qualified Welders:** Yes No N/A**Verified Joint Fit-up:** Yes No N/A**Approved Drawings:** Yes No N/A**Approved WPS:** Yes No N/A**Delayed / Cancelled:** Yes No N/A**Bridge No:** 34-0006**Component:** Tower**Summary of Items Observed:**

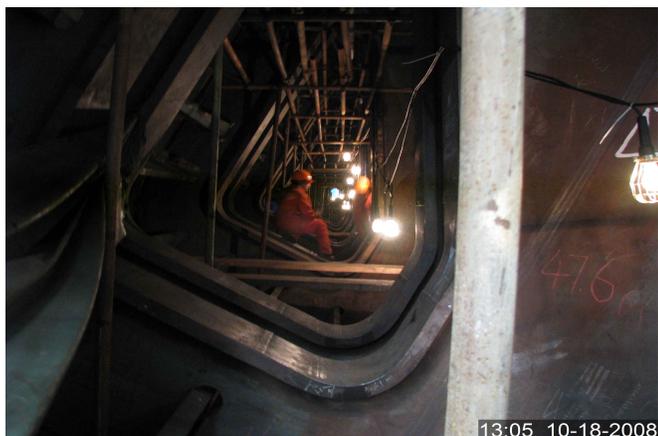
**South Shaft, Skin C, Lift 1**

ZPMC was in the process of building up the longitudinal stiffeners and skin plate by welding (buttering) utilizing the flux cored arc welding process. ZPMC's internal weld repair report stated the amount of buttering would be 8 mm. QA observed as much as 15 mm. Below is a digital photograph illustrating the build up in progress.
