DEPARTMENT OF TRANSPORTATION

Contract #: 04-0120F4Cty: SF/ALA Rte: 80 PM: 13.2/13.9File #: 69.28**WELDING INSPECTION REPORT****Resident Engineer:** Pursell, Gary**Address:** 333 Burma Road**City:** Oakland, CA 94607**Report No:** WIR-004278**Date Inspected:** 21-Oct-2008**Project Name:** SAS Superstructure**OSM Arrival Time:** 700**Prime Contractor:** American Bridge/Fluor Enterprises, a JV**OSM Departure Time:** 1700**Contractor:** Zhenhua Port Machinery Company, Ltd (ZPMC), Changxing Island **Location:** Shanghai, China**CWI Name:** Sun Wei**CWI Present:** Yes No**Inspected CWI report:** Yes No N/A**Rod Oven in Use:** Yes No N/A**Electrode to specification:** Yes No N/A**Weld Procedures Followed:** Yes No N/A**Qualified Welders:** Yes No N/A**Verified Joint Fit-up:** Yes No N/A**Approved Drawings:** Yes No N/A**Approved WPS:** Yes No N/A**Delayed / Cancelled:** Yes No N/A**Bridge No:** 34-0006**Component:** Tower**Summary of Items Observed:**

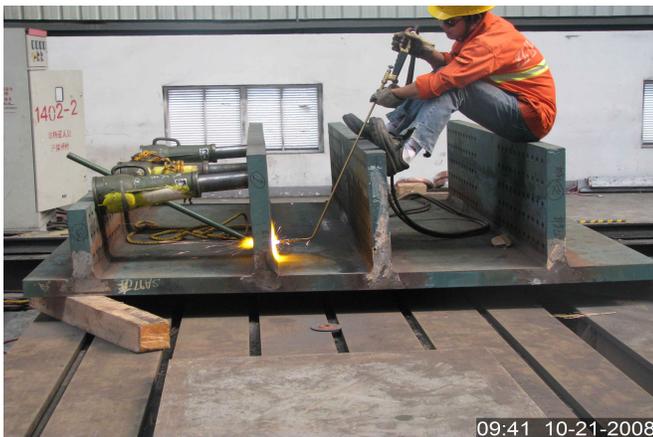
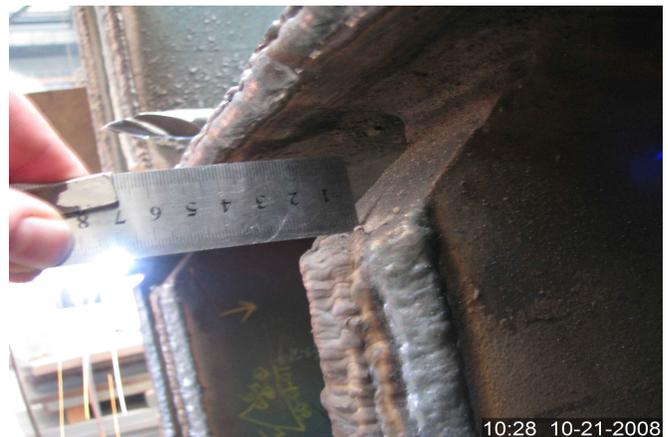
The Quality Assurance Inspector generated an incident report pertaining ZPMC building up the East Shaft, Skin E, Lift 1 and South Shaft, Skin C, Lift 1, Longitudinal Stiffeners by welding. ZPMC was utilizing the weave bead technique to build up the joints making the travel speed tolerances not comply with welding procedure specification WPS-345-FCAW-3G-3F-Repair. The width of the weave bead observed was approximately 50 millimeters. Below is a digital photograph illustrating the weave bead.
