**DEPARTMENT OF TRANSPORTATION**

Contract #: 04-0120F4Cty: SF/ALA Rte: 80 PM: 13.2/13.9File #: 69.28**WELDING INSPECTION REPORT****Resident Engineer:** Pursell, Gary**Address:** 333 Burma Road**City:** Oakland, CA 94607**Report No:** WIR-004279**Date Inspected:** 23-Oct-2008**Project Name:** SAS Superstructure**OSM Arrival Time:** 700**Prime Contractor:** American Bridge/Fluor Enterprises, a JV**OSM Departure Time:** 1700**Contractor:** Zhenhua Port Machinery Company, Ltd (ZPMC), Changxing Island **Location:** Shanghai, China**CWI Name:** Sun Wei**CWI Present:** Yes No**Inspected CWI report:** Yes No N/A**Rod Oven in Use:** Yes No N/A**Electrode to specification:** Yes No N/A**Weld Procedures Followed:** Yes No N/A**Qualified Welders:** Yes No N/A**Verified Joint Fit-up:** Yes No N/A**Approved Drawings:** Yes No N/A**Approved WPS:** Yes No N/A**Delayed / Cancelled:** Yes No N/A**Bridge No:** 34-0006**Component:** Tower**Summary of Items Observed:**

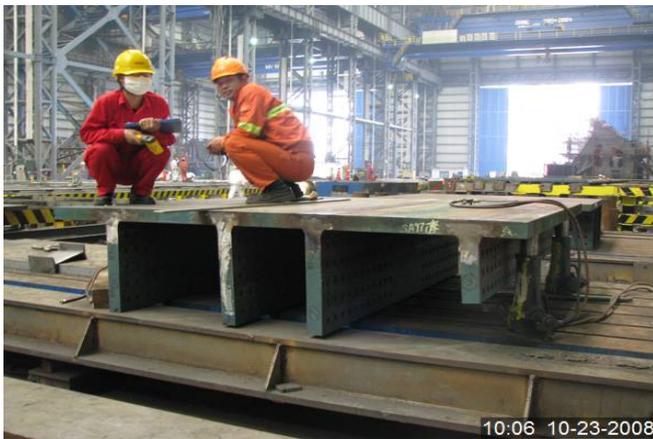
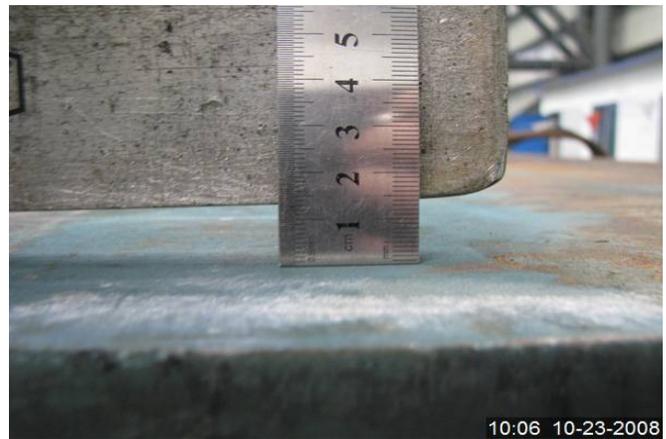
The Quality Assurance Inspector generated an incident report pertaining to ZPMC performing heat straightening operations to an Internal Splice Plate identified as ESD1-SA97. ZPMC submitted heat straightening request HSR(T)-205 which stated the maximum deformation was 10 millimeters. QA measured the member to be out of flatness to be approximately 14 millimeters as shown in the digital photographs below.
