Quality Assurance and Source Inspection

Contract #: 04-0120F4Cty: SF/ALA Rte: 80 PM: 13.2/13.9File #: 69.28**WELDING INSPECTION REPORT****Resident Engineer:** Pursell, Gary**Address:** 333 Burma Road**City:** Oakland, CA 94607**Report No:** WIR-004281**Date Inspected:** 27-Oct-2008**Project Name:** SAS Superstructure**OSM Arrival Time:** 700**Prime Contractor:** American Bridge/Fluor Enterprises, a JV**OSM Departure Time:** 1700**Contractor:** Zhenhua Port Machinery Company, Ltd (ZPMC), Changxing Island **Location:** Shanghai, China**CWI Name:** Sun Wei**CWI Present:** Yes No**Inspected CWI report:** Yes No N/A**Rod Oven in Use:** Yes No N/A**Electrode to specification:** Yes No N/A**Weld Procedures Followed:** Yes No N/A**Qualified Welders:** Yes No N/A**Verified Joint Fit-up:** Yes No N/A**Approved Drawings:** Yes No N/A**Approved WPS:** Yes No N/A**Delayed / Cancelled:** Yes No N/A**Bridge No:** 34-0006**Component:** Tower**Summary of Items Observed:**

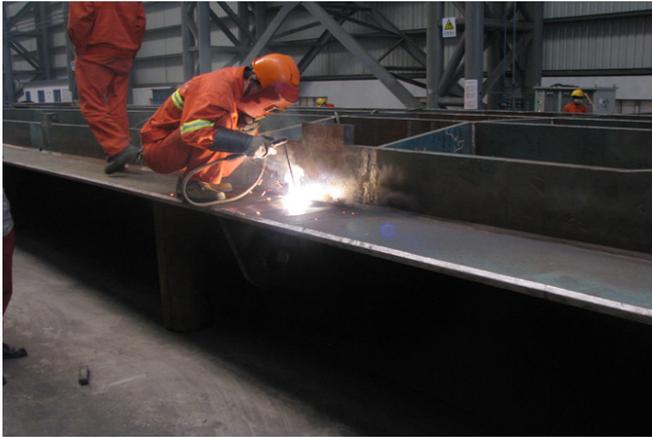
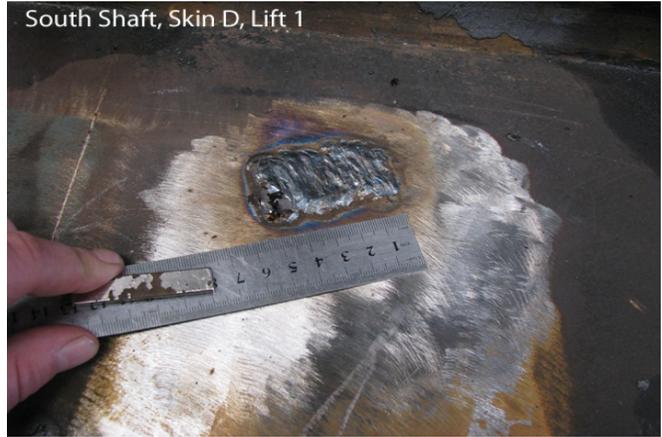
South Shaft, Skin D, Lift 1

ZPMC was observed performing base metal repairs to the base metal where temporary lifting aids were removed without prior approval from the Engineer. An incident report was generated pertaining to the discrepancy. Below are digital photographs of the repairs in progress.
