DEPARTMENT OF TRANSPORTATION

Contract #: 04-0120F4Cty: SF/ALA Rte: 80 PM: 13.2/13.9File #: 69.28**WELDING INSPECTION REPORT****Resident Engineer:** Pursell, Gary**Address:** 333 Burma Road**City:** Oakland, CA 94607**Report No:** WIR-004323**Date Inspected:** 28-Oct-2008**Project Name:** SAS Superstructure**OSM Arrival Time:** 700**Prime Contractor:** American Bridge/Fluor Enterprises, a JV**OSM Departure Time:** 1700**Contractor:** Zhenhua Port Machinery Company, Ltd (ZPMC), Changxing Island **Location:** Shanghai, China**CWI Name:** Sun Wei**CWI Present:** Yes No**Inspected CWI report:** Yes No N/A**Rod Oven in Use:** Yes No N/A**Electrode to specification:** Yes No N/A**Weld Procedures Followed:** Yes No N/A**Qualified Welders:** Yes No N/A**Verified Joint Fit-up:** Yes No N/A**Approved Drawings:** Yes No N/A**Approved WPS:** Yes No N/A**Delayed / Cancelled:** Yes No N/A**Bridge No:** 34-0006**Component:** Tower**Summary of Items Observed:**

East Shaft Lift 1

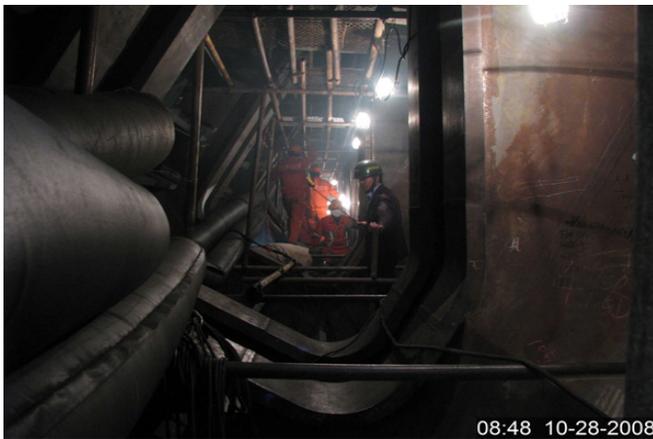
The Quality Assurance Inspector observed ZPMC continuing to work in the confined spaces. Approximately 20 ZPMC employees were observed in the shaft. ZPMC safety officer was observed using an air monitor within the shaft. Below is a digital photograph. ABF Representative Mike Williams informed the Quality Assurance Inspector that ZPMC and ABF have performed final visual and applicable non destructive testing on Skin Plates A and B. The Quality Assurance Inspector relayed that once we have approval to enter the confined space the inspections would be completed at that time. No work was observed being performed on the exterior of the shaft today.
