**DEPARTMENT OF TRANSPORTATION**

Contract #: 04-0120F4Cty: SF/ALA Rte: 80 PM: 13.2/13.9File #: 69.28**WELDING INSPECTION REPORT****Resident Engineer:** Pursell, Gary**Address:** 333 Burma Road**City:** Oakland, CA 94607**Report No:** WIR-004356**Date Inspected:** 07-Oct-2008**Project Name:** SAS Superstructure**OSM Arrival Time:** 700**Prime Contractor:** American Bridge/Fluor Enterprises, a JV**OSM Departure Time:** 1700**Contractor:** Zhenhua Port Machinery Company, Ltd (ZPMC), Changxing Island **Location:** Shanghai, China**CWI Name:** Sun Wei**CWI Present:** Yes No**Inspected CWI report:** Yes No N/A**Rod Oven in Use:** Yes No N/A**Electrode to specification:** Yes No N/A**Weld Procedures Followed:** Yes No N/A**Qualified Welders:** Yes No N/A**Verified Joint Fit-up:** Yes No N/A**Approved Drawings:** Yes No N/A**Approved WPS:** Yes No N/A**Delayed / Cancelled:** Yes No N/A**Bridge No:** 34-0006**Component:** Tower**Summary of Items Observed:**

# WELDING INSPECTION REPORT

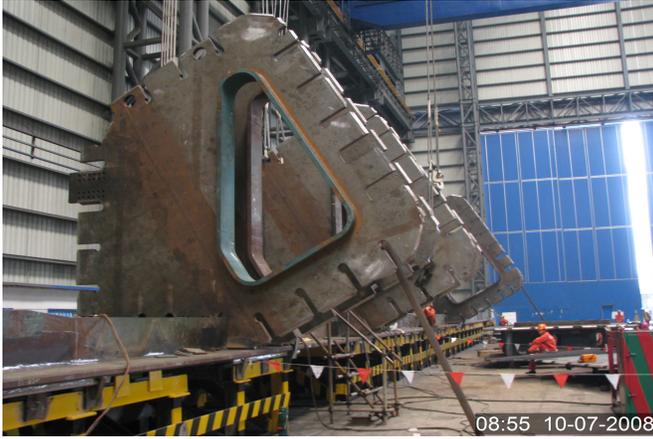
The Quality Assurance Inspector observed ZPMC fitting up and tack welding the 9M, 23M, 28M and 43M Diaphragm Plate assemblies on to the South Shaft, Skin A, assembly. Three ZPMC welders were utilizing the shielded metal arc welding process to produce the tack welds. Below is a digital photograph illustrating the erection in progress of the 33M diaphragm plate.
