Contract #: 04-0120F4Cty: SF/ALA Rte: 80 PM: 13.2/13.9File #: 69.28**WELDING INSPECTION REPORT****Resident Engineer:** Pursell, Gary**Address:** 333 Burma Road**City:** Oakland, CA 94607**Report No:** WIR-004435**Date Inspected:** 27-Oct-2008**Project Name:** SAS Superstructure**OSM Arrival Time:** 2230**Prime Contractor:** American Bridge/Fluor Enterprises, a JV**OSM Departure Time:** 730**Contractor:** Zhenhua Port Machinery Company, Ltd (ZPMC), Changxing Island **Location:** Shanghai, China**CWI Name:****CWI Present:**

Bridge No: 34-0006**Component:** OBG & Tower**Summary of Items Observed:**

Caltrans Quality Assurance (QA) Inspector, Mike Hasler was present to observe the fitup, welding and related activities associated with the fabricating of Caltrans Orthotropic Box Girder (OBG) and Tower, for the San Francisco Oakland Bay Self Anchored Suspension Bridge, at Zhenhua Port Machinery Company (ZPMC) facility on Changxing Island.

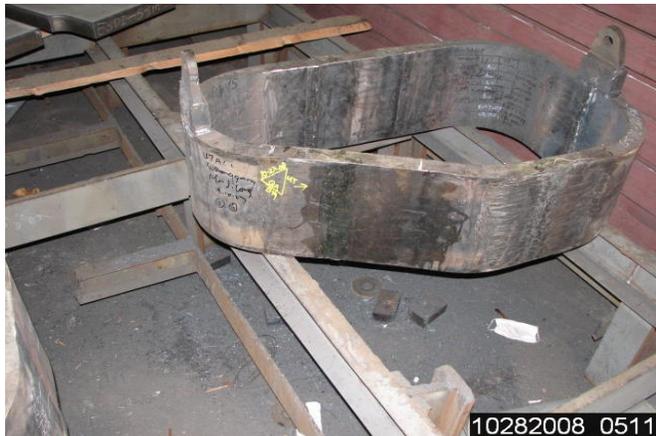
Item	Description	WBS	Dwg No.	Status
1	Tower Diaph. Flange	NA	NA	QA-UT

Bay 4: Caltrans QA inspector performed ultrasonic test (UT) inspection per ZPMC notification of witness inspection, document number 001295. The subassemblies are identified as Lift 2 tower diaphragm flange, weld SSD1-SA104A/B-9 and ESD1-SA425A/B-6. Caltrans QA inspector observed that the welds have been UT inspected and identified as accepted by ZPMC QC-MT inspector, Mr. Xu Rong Gang. Caltrans QA-UT coverage was approximately 100%. The welds appeared to be in conformance with the project specifications. See Caltrans Ultrasonic Test Report (TL-6027) dated, October 27, 2008 for additional information. The following digital picture illustrates QA-UT inspection of weld ESD1-SA425A/B-6.

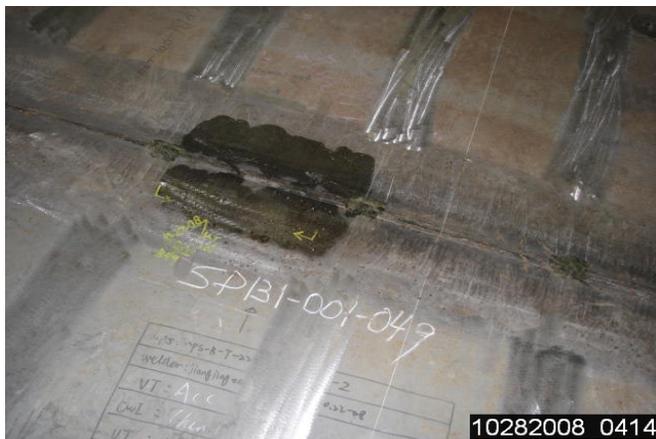
2 Side Plates NA NA QA-UT
OBG

Bay 3: Caltrans QA inspector performed ultrasonic test (UT) inspection per ZPMC notification of witness inspection, document number 001295. The subassemblies are identified as side plates, weld SP577-001-091, SP371-001-049, SP131-001-049, SP104-001-057, SP158-001-049, SP317-001-071 and SP344-001-049. Caltrans QA inspector observed that the welds have been UT inspected and identified as accepted by ZPMC QC-MT inspector, Mr. Jiao Jifeng. Caltrans QA-UT coverage was approximately 10%. The welds appeared to be in conformance with the project specifications. See Caltrans Ultrasonic Test Report (TL-6027) dated, October 27, 2008 for additional information. The following digital picture illustrates QA-UT inspection of weld SP131-001-049.
