DEPARTMENT OF TRANSPORTATION

Contract #: 04-0120F4Cty: SF/ALA Rte: 80 PM: 13.2/13.9File #: 69.28**WELDING INSPECTION REPORT****Resident Engineer:** Pursell, Gary**Address:** 333 Burma Road**City:** Oakland, CA 94607**Report No:** WIR-004456**Date Inspected:** 25-Oct-2008**Project Name:** SAS Superstructure**OSM Arrival Time:** 630**Prime Contractor:** American Bridge/Fluor Enterprises, a JV**OSM Departure Time:** 1530**Contractor:** Zhenhua Port Machinery Company, Ltd (ZPMC), Changxing Island **Location:** Shanghai, China**CWI Name:** Huang Wen Pang**CWI Present:** Yes No**Inspected CWI report:** Yes No N/A**Rod Oven in Use:** Yes No N/A**Electrode to specification:** Yes No N/A**Weld Procedures Followed:** Yes No N/A**Qualified Welders:** Yes No N/A**Verified Joint Fit-up:** Yes No N/A**Approved Drawings:** Yes No N/A**Approved WPS:** Yes No N/A**Delayed / Cancelled:** Yes No N/A**Bridge No:** 34-0006**Component:** OBG & Tower**Summary of Items Observed:**

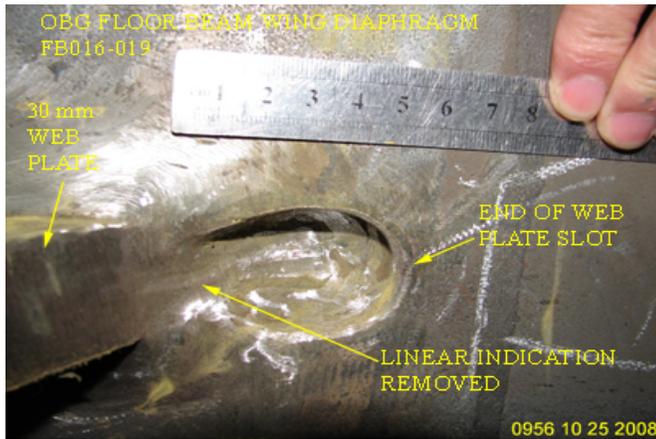
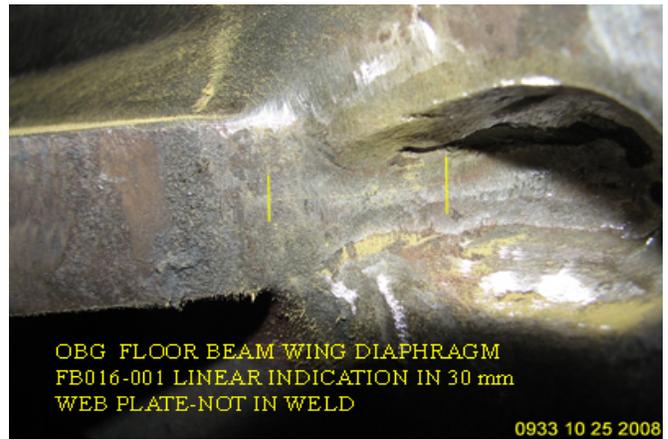
The QA Inspector was requested by ZPMC QC Representative Shen Xue Jun, to perform a final Magnetic Particle Testing (MT) Verification on Floor Beam Wing Diaphragm FB016-009 and informed the QA Inspector that it was in the middle of OBG Sub-Assembly Bay 7. The QA Inspector along with ZPMC and ABF QC personnel could not immediately locate FB016-009. ABF QC asked ZPMC production where the panel was located and ZPMC production informed ABF that the panel had been moved to the front of Bay 7. The QA Inspector then located FB016-009 and observed that it had been flipped to Side B and that bolt holes had been drilled at the edges of the web. The QA Inspector also randomly observed that the panel was covered in cutting oil and metal from the bolt hole drilling. The QA Inspector also randomly observed several of the welds covered in rust. The QA Inspector requested from Shen Xue Jun, that the panel be cleaned and that all cutting oil, metal from drilling and rust be removed. Mr. Shen directed ZPMC welding personnel to do the cleaning. The QA Inspector then performed a 10% final Visual (VT) and MT verification on the cover pass of all the welds on Floor Beam Wing Diaphragms FB016-009 Side A. The QA Inspector randomly observed a linear indication on the edge of the 30 millimeter (mm) web plate which extended through Flange X7J-8. The linear indication was not in any weld and was entirely located in the base metal of the web plate. ZPMC CWI CHuang Wen Pang, directed ZPMC production to grind the area lightly with a pencil grinder. The QA Inspector re-examined the area and the linear

indication appeared to have been removed. The QA Inspector continued with the rest of the MT Verification and there appeared to be no further indications. The QA Inspector accepted all welds on the above listed Floor Beam Wing Diaphragms and initialed the In Process Yellow Tag. The attached photographs provide additional detail.
