DEPARTMENT OF TRANSPORTATION

Contract #: 04-0120F4Cty: SF/ALA Rte: 80 PM: 13.2/13.9File #: 69.28**WELDING INSPECTION REPORT****Resident Engineer:** Pursell, Gary**Address:** 333 Burma Road**City:** Oakland, CA 94607**Report No:** WIR-004604**Date Inspected:** 13-Oct-2008**Project Name:** SAS Superstructure**OSM Arrival Time:** 700**Prime Contractor:** American Bridge/Fluor Enterprises, a JV**OSM Departure Time:** 1700**Contractor:** Zhenhua Port Machinery Company, Ltd (ZPMC), Changxing Island **Location:** Shanghai, China**CWI Name:** Sun Wei**CWI Present:** Yes No**Inspected CWI report:** Yes No N/A**Rod Oven in Use:** Yes No N/A**Electrode to specification:** Yes No N/A**Weld Procedures Followed:** Yes No N/A**Qualified Welders:** Yes No N/A**Verified Joint Fit-up:** Yes No N/A**Approved Drawings:** Yes No N/A**Approved WPS:** Yes No N/A**Delayed / Cancelled:** Yes No N/A**Bridge No:** 34-0006**Component:** Tower**Summary of Items Observed:**

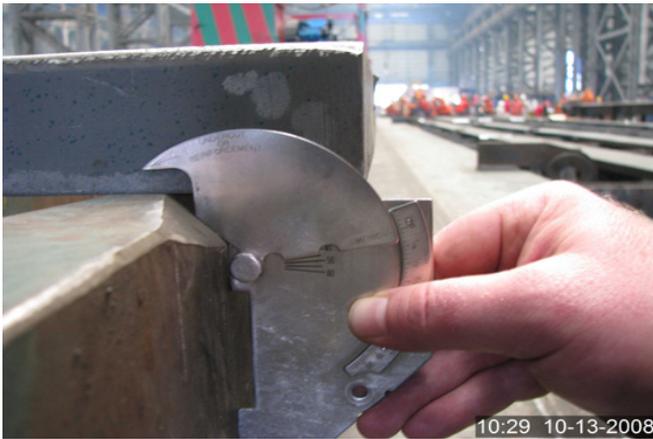
The Quality Assurance Inspector observed ZPMC performing fit-up and tack welding operations of the connection plate to longitudinal stiffener partial joint penetration connection. ZPMC was utilizing the shielded metal arc welding process to produce the tack weld in the horizontal position. The Quality Assurance Inspector measured the

bevel angle of the partial joint penetration weld to be approximately 45 degrees as illustrated in the digital photograph below.
