DEPARTMENT OF TRANSPORTATION

Contract #: 04-0120F4Cty: SF/ALA Rte: 80 PM: 13.2/13.9File #: 69.28**WELDING INSPECTION REPORT****Resident Engineer:** Pursell, Gary**Address:** 333 Burma Road**City:** Oakland, CA 94607**Report No:** WIR-004636**Date Inspected:** 30-Oct-2008**Project Name:** SAS Superstructure**OSM Arrival Time:** 700**Prime Contractor:** American Bridge/Fluor Enterprises, a JV**OSM Departure Time:** 1700**Contractor:** Zhenhua Port Machinery Company, Ltd (ZPMC), Changxing Island **Location:** Shanghai, China**CWI Name:** Sun Wei**CWI Present:** Yes No**Inspected CWI report:** Yes No N/A**Rod Oven in Use:** Yes No N/A**Electrode to specification:** Yes No N/A**Weld Procedures Followed:** Yes No N/A**Qualified Welders:** Yes No N/A**Verified Joint Fit-up:** Yes No N/A**Approved Drawings:** Yes No N/A**Approved WPS:** Yes No N/A**Delayed / Cancelled:** Yes No N/A**Bridge No:** 34-0006**Component:** Tower and OBG**Summary of Items Observed:**

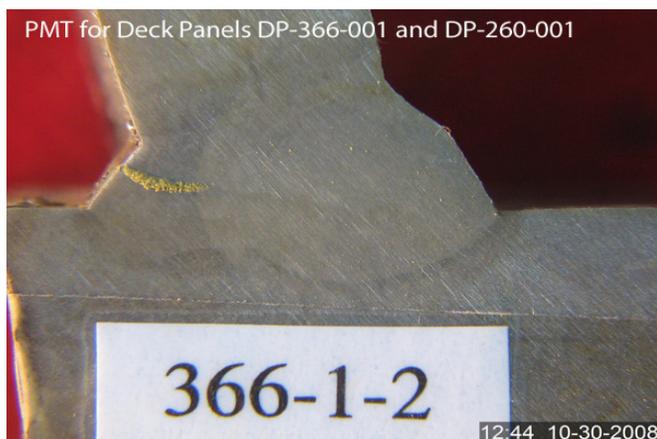
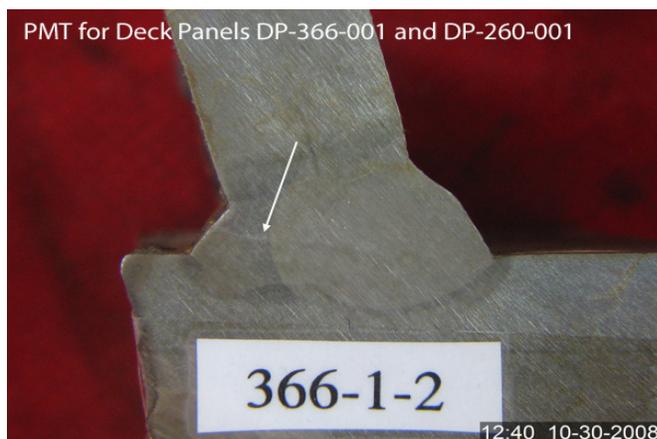
Production Monitoring Test Macro Etch Samples

The Quality Assurance Inspector was instructed to perform a second review of the macro etch samples from the PMT welded this morning after it was found compliant by ZPMC, ABF and Caltrans. The PMT was for Deck Panels DP-366-001 and DP-260-001. In addition the instructions were to perform magnetic particle testing to all fifteen samples. The Quality Assurance Inspector observed a crack in sample 366-1-2. Mr. John Kinsey and Structures Materials Representative were made aware of the findings and requested the two digital photographs below.
