DEPARTMENT OF TRANSPORTATION

Contract #: 04-0120F4Cty: SF/ALA Rte: 80 PM: 13.2/13.9File #: 69.28**WELDING INSPECTION REPORT****Resident Engineer:** Pursell, Gary**Address:** 333 Burma Road**City:** Oakland, CA 94607**Report No:** WIR-004769**Date Inspected:** 10-Nov-2008**Project Name:** SAS Superstructure**OSM Arrival Time:** 1330**Prime Contractor:** American Bridge/Fluor Enterprises, a JV**OSM Departure Time:** 2230**Contractor:** Zhenhua Port Machinery Company, Ltd (ZPMC), Changxing Island **Location:** Shanghai, China

CWI Name:	NA	CWI Present:	Yes	No
Inspected CWI report:	Yes No N/A	Rod Oven in Use:	Yes No N/A	
Electrode to specification:	Yes No N/A	Weld Procedures Followed:	Yes No N/A	
Qualified Welders:	Yes No N/A	Verified Joint Fit-up:	Yes No N/A	
Approved Drawings:	Yes No N/A	Approved WPS:	Yes No N/A	
		Delayed / Cancelled:	Yes No N/A	
Bridge No:	34-0006	Component:	OBG Fabrication

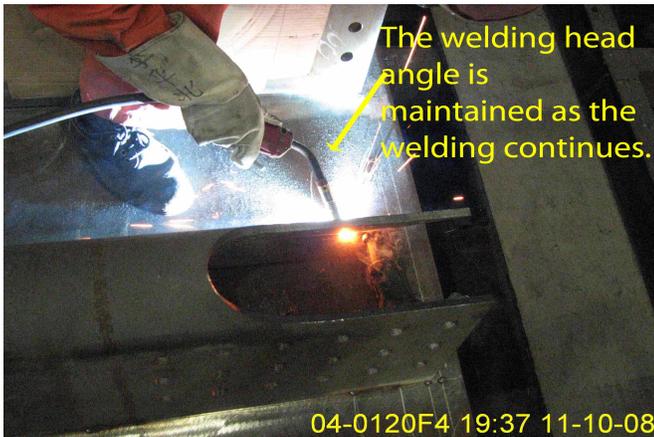
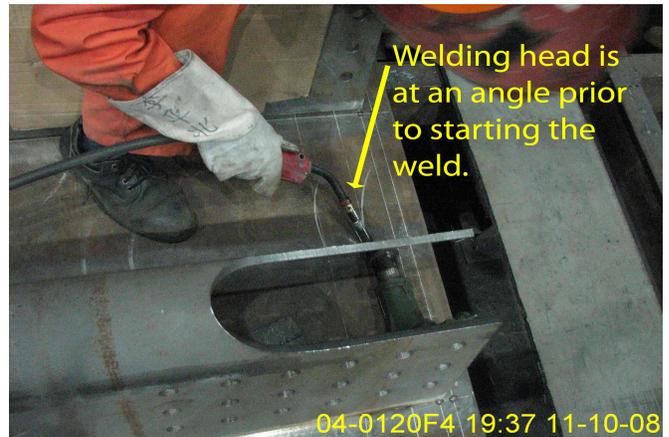
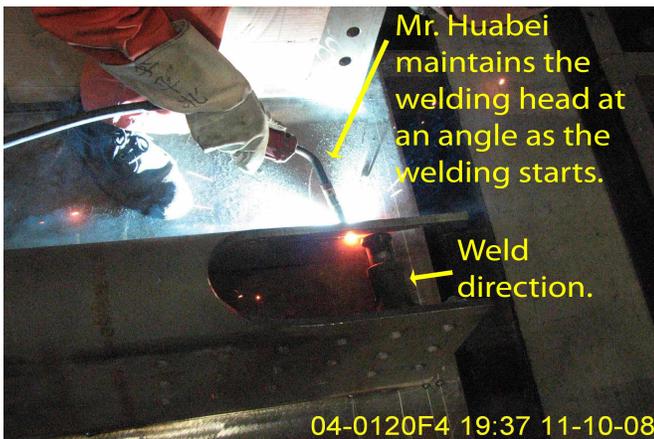
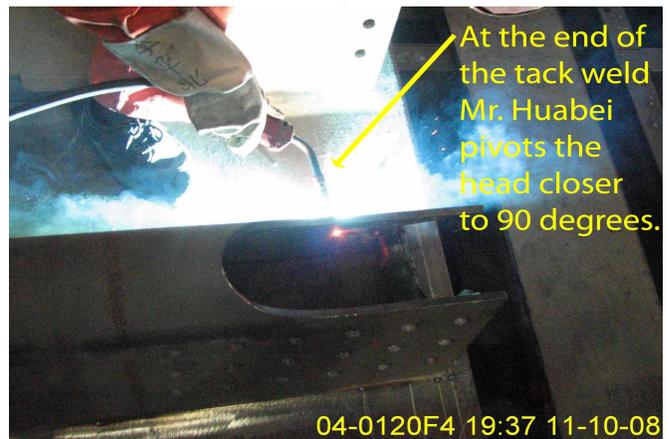
The Caltrans QA Inspector arrived in OBG bay 1 at around 1845 hrs for observations of ZPMC using tack welding procedure number WPS-B-T-2342-U5(U-rib) to tack weld closed ribs onto deck panel DP346-001. The QA Inspector observed 1.4mm diameter GMAW welding electrode JM-56 lot number 80727915 were being used by ZPMC welders Mr. Lu Liang, stencil #059373 on the east end of the deck panel and Mr. Li Huabei stencil #59472 on the west end of the deck panel. During the hour when this QA Inspector was in OBG Bay #1 the QA Inspector observed no ZPMC CWI or Quality Control personnel were in this bay as the welding was being performed. The WPS specifications require the angle of the welding head is to be a minimum of 90 degrees and that the weld puddle should be pushed and not "dragged".

ZPMC welder Mr. Lu Liang, stencil #059373 was observed to have a welding current of approximately 340 amps, 25.3 volts and a shielding gas flow of 23 Liters per minute. Mr. Liang appears to be holding the welding head at an angle of approximately 90 degrees from the weld joint. Items observed by the QA Inspector appear to comply with project specifications.

ZPMC welder Mr. Li Huabei, stencil #059472 was observed to have a welding current of approximately 340 amps, 26.3 volts and a shielding gas flow of 23 Liters per minute. Mr. Liang appears to be holding the welding head at an angle of approximately 75 to 80 degrees slanted toward the direction of welding progression. Mr. Liang appears to be “Dragging” the weld puddle. See the photographs below for additional information. Items observed by the QA Inspector do not appear to fully comply with project specifications.

The QA Inspector performed random AWS D1.5 visual and ultrasonic inspections of Floor Beam welds FB025-003-117, FB025-003-122 and FB025-003-101 as listed on the ZPMC Notification of Witness Inspection document #1386 and the welds appear to comply with project specifications. For additional information on these inspections see the TL6027 Ultrasonic Test Report.

The Notification of Witness Inspection document #1386 also lists several other floor beam welds that were to be inspected by ZPMC personnel at around 1340 hours and the QA Inspector observed several of these welds that were listed do not appear to have been ultrasonically inspected by ZPMC personnel.
