**DEPARTMENT OF TRANSPORTATION**

Contract #: 04-0120F4Cty: SF/ALA Rte: 80 PM: 13.2/13.9File #: 69.28**WELDING INSPECTION REPORT****Resident Engineer:** Pursell, Gary**Address:** 333 Burma Road**City:** Oakland, CA 94607**Report No:** WIR-004789**Date Inspected:** 22-Nov-2008**Project Name:** SAS Superstructure**OSM Arrival Time:** 1400**Prime Contractor:** American Bridge/Fluor Enterprises, a JV**OSM Departure Time:** 2200**Contractor:** Zhenhua Port Machinery Company, Ltd (ZPMC), Changxing Island **Location:** Changxing Island, Shanghai**CWI Name:** Kim Xiao, Zhang Qin Jian**CWI Present:** Yes No**Inspected CWI report:** Yes No N/A**Rod Oven in Use:** Yes No N/A**Electrode to specification:** Yes No N/A**Weld Procedures Followed:** Yes No N/A**Qualified Welders:** Yes No N/A**Verified Joint Fit-up:** Yes No N/A**Approved Drawings:** Yes No N/A**Approved WPS:** Yes No N/A**Delayed / Cancelled:** Yes No N/A**Bridge No:** 34-0006**Component:** Tower components**Summary of Items Observed:**

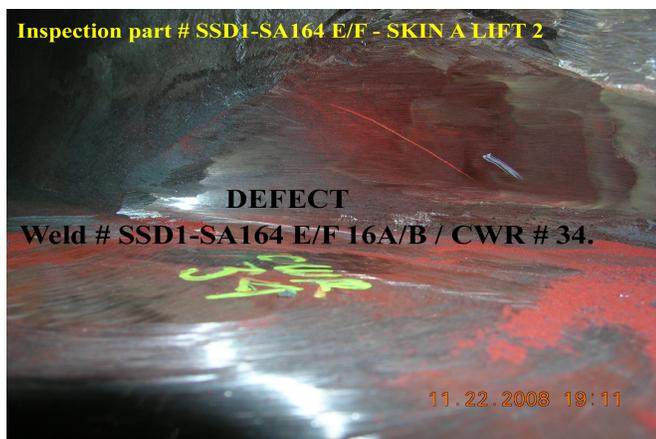
2. The QA Inspector was requested by the ZPMC QC Inspection personnel to observe a weld defect found during an excavation on a complete joint penetration weld number SSD1-SA164 E/F 16A/B made between longitudinal

stiffener number A2 on side B and skin plate on inspection part number SSD1-SA164 E/F on the SKIN A LIFT 2 assembly of the tower section. The QA Inspector was notified by the QC Inspection personnel the excavation was being performed to remove a weld discontinuity found by QC Inspectors during the UT after the weld was completed. The excavation is part of a Critical Weld Repair (CWR) number 34. The QC Inspection personnel notified QA Inspector the CWR documentation was not submitted as of this time but it will be submitted on 11-24-08 during the day shift. The QA Inspector was also notified ABF personnel "Steve" notified the Caltrans Engineer of the CWR number 34, 35 and 36 by email (document showed to QA Inspector). At the location the QA Inspector observed the found defect that appeared to be a linear transverse indication. Please see digital images below for additional information. The QA Inspector notified Task Leader Robert Cuellar and Lead QA Inspector Paul Dawson of the not submitted CWR documentation and the discovered defect. The QA Inspector periodically observed ZPMC personnel removing the defect by grinding in the presence of the QC Inspection personnel. After defect was removed the QC Inspection personnel performed Magnetic Particle Testing (MT) on the excavated area. The QC Inspection personnel notified QA Inspector no additional welding discontinuities were found and the excavated area was reported to be acceptable. At this location the QA Inspector performed visual and MT verifications on the entire excavation and observed the excavated area to be in general compliance. Please see the QA Inspector's Magnetic Particle Testing (TL 6028) report generated on this date for additional information.
