DEPARTMENT OF TRANSPORTATION

Contract #: 04-0120F4Cty: SF/ALA Rte: 80 PM: 13.2/13.9File #: 13.28**WELDING INSPECTION REPORT****Resident Engineer:** Pursell, Gary**Address:** 333 Burma Road**City:** Oakland, CA 94607**Report No:** WIR-004907**Date Inspected:** 11-Dec-2008**Project Name:** SAS Superstructure**OSM Arrival Time:** 800**Prime Contractor:** American Bridge/Fluor Enterprises, a JV**OSM Departure Time:** 1530**Contractor:** Oregon Iron Works Clackamas, Or.**Location:** Clackamas, Oregon

Bridge No: 34-0006**Component:** Hinge K components**Summary of Items Observed:**

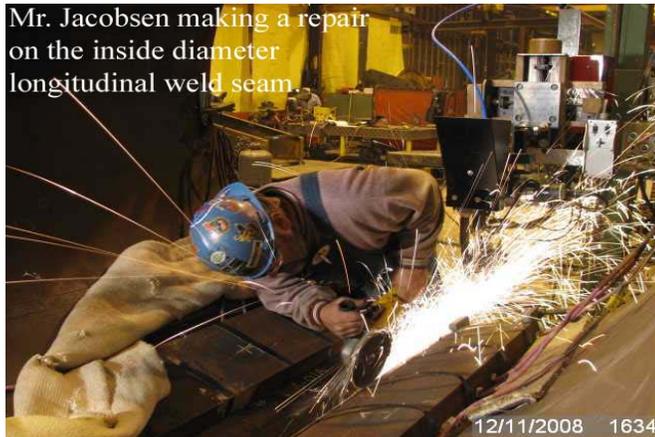
The QA Inspector then observed Mr. Jacobsen deposit the root pass on the inside diameter of the Fuse. Upon completion and cleaning of the weld the QA Inspector observed what appeared to be (2) porosity holes approximately 3 mm in diameter in the above mentioned weld at different locations. Mr. Jacobsen was observed

utilizing a grinder to remove the porosity and tapered the repair areas. Please see photo below for confirming information. Mr. Jacobsen then performed SAW to make repairs. The QA Inspector observed that the welding parameters appeared to be in compliance with welding procedure specification (WPS) 4020 Revision 0.
