Contract #: 04-0120F4Cty: SF/ALA Rte: 80 PM: 13.2/13.9File #: 13.28**WELDING INSPECTION REPORT****Resident Engineer:** Pursell, Gary**Address:** 333 Burma Road**City:** Oakland, CA 94607**Report No:** WIR-004935**Date Inspected:** 12-Dec-2008**Project Name:** SAS Superstructure**OSM Arrival Time:** 530**Prime Contractor:** American Bridge/Fluor Enterprises, a JV**OSM Departure Time:** 1600**Contractor:** Oregon Iron Works Clackamas, Or.**Location:** Clackamas, Oregon

Bridge No: 34-0006**Component:** Hinge K components**Summary of Items Observed:**

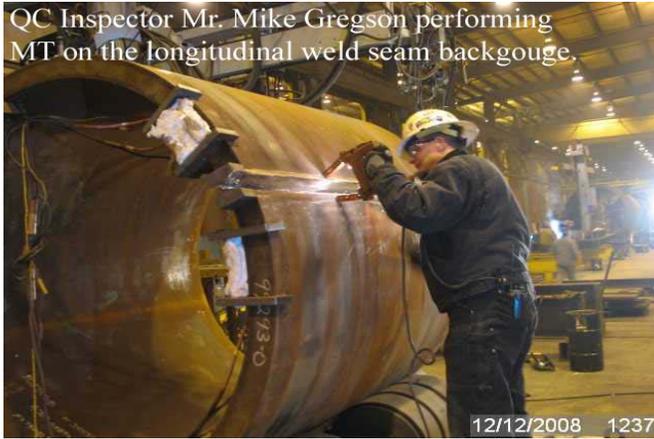
The QA Inspector observed that Cooper heating elements were on and continued to pre-heat and maintain interpass temperature of the Fuse weld joint area.

The QA Inspector did observe that Welding Operator Mr. Craig Jacobsen, welder identification (WID) #J6 deposited weld metal on the inside diameter of the complete joint penetration longitudinal weld seam marked as #W3-01A on Fuse Heat #D5551-6A utilizing 3/32 inch diameter Lincoln LA-85 submerged arc welding (SAW) wire and Lincoln MIL 800-HPNi granular flux. Following the above mentioned welding Mr. Jacobsen utilized carbon arc cutting to backgouge the root of the weld on the outside diameter of the Fuse. Mr. Jacobsen then utilized a grinder to dress the weld joint and the QA Inspector observed Quality Control (QC) Inspector Mr. Mike Gregson performed magnetic particle (MT) inspection on 100% of the weld joint and the immediate surrounding area. Please see photo below for additional information. Mr. Gregson indicated several locations which contained indications. Mr. Jacobsen utilized a die grinder to dress the above mentioned areas and Mr. Gregson performed MT on the areas addressed and accepted the backgouge. Mr. Jacobsen then deposited weld metal on the outside diameter of the weld joint. The QA Inspector observed that the welding parameters appeared to be in compliance with welding procedure specification (WPS) 4020 Revision 0.
