Contract #: 04-0120F4Cty: SF/ALA Rte: 80 PM: 13.2/13.9File #: 13.28**WELDING INSPECTION REPORT****Resident Engineer:** Pursell, Gary**Address:** 333 Burma Road**City:** Oakland, CA 94607**Report No:** WIR-005016**Date Inspected:** 17-Dec-2008**Project Name:** SAS Superstructure**OSM Arrival Time:** 600**Prime Contractor:** American Bridge/Fluor Enterprises, a JV**OSM Departure Time:** 1630**Contractor:** Oregon Iron Works Clackamas, Or.**Location:** Clackamas, Oregon

**Bridge No:** 34-0006**Component:** Hinge K components**Summary of Items Observed:**

# WELDING INSPECTION REPORT

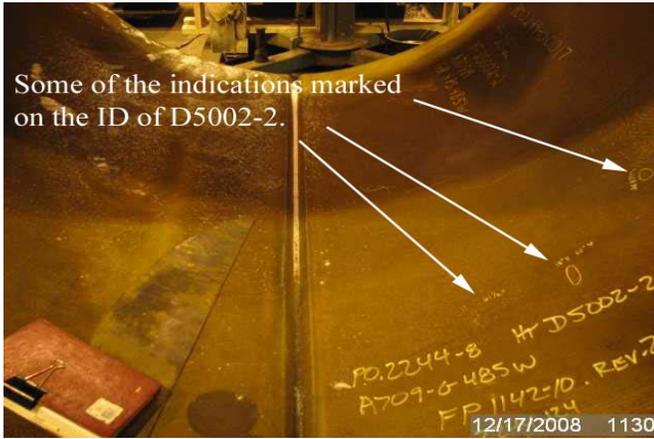
The QA Inspector met with Supervisor Mr. Joe Adame and QA Inspector Mr. Rick Bettencourt at the OIW shop in Portland, Oregon and discussed the issue with the indications which exist on the inside diameter of Fuse D5551-6A as well as D5002-2 (please see photo below for confirming information). The QA Inspector pointed

out several examples of these areas to Mr. Adame and Mr. Bettencourt and informed the above mentioned inspectors that OIW is currently exploring options on how to proceed on this issue.
