DEPARTMENT OF TRANSPORTATION

Contract #: 04-0120F4Cty: SF/ALA Rte: 80 PM: 13.2/13.9File #: 69.28**WELDING INSPECTION REPORT****Resident Engineer:** Pursell, Gary**Address:** 333 Burma Road**City:** Oakland, CA 94607**Report No:** WIR-005174**Date Inspected:** 12-Jan-2009**Project Name:** SAS Superstructure**OSM Arrival Time:** 700**Prime Contractor:** American Bridge/Fluor Enterprises, a JV**OSM Departure Time:** 1900**Contractor:** Zhenhua Port Machinery Company, Ltd (ZPMC), Changxing Island **Location:** Shanghai, China**CWI Name:** Shen Fuyou**CWI Present:** Yes No**Inspected CWI report:** Yes No N/A**Rod Oven in Use:** Yes No N/A**Electrode to specification:** Yes No N/A**Weld Procedures Followed:** Yes No N/A**Qualified Welders:** Yes No N/A**Verified Joint Fit-up:** Yes No N/A**Approved Drawings:** Yes No N/A**Approved WPS:** Yes No N/A**Delayed / Cancelled:** Yes No N/A**Bridge No:** 34-0006**Component:** cross braces and OBG segments**Summary of Items Observed:**

WELDING INSPECTION REPORT

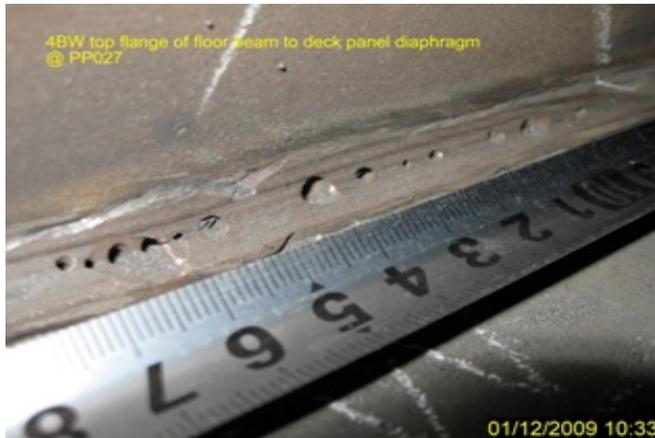
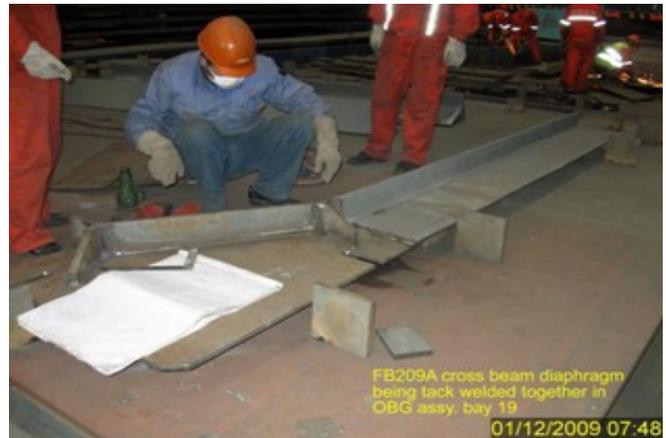
QA noted numerous non compliant nicks and gouges in base metal surfaces and edges that have not yet been repaired by the contractor throughout the entire segment.
