**DEPARTMENT OF TRANSPORTATION**

Contract #: 04-0120F4Cty: SF/ALA Rte: 80 PM: 13.2/13.9File #: 70.28**WELDING INSPECTION REPORT****Resident Engineer:** Pursell, Gary**Address:** 333 Burma Road**City:** Oakland, CA 94607**Report No:** WIR-005248**Date Inspected:** 21-Jan-2009**Project Name:** SAS Superstructure**OSM Arrival Time:** 830**Prime Contractor:** American Bridge/Fluor Enterprises, a JV**OSM Departure Time:** 1930**Contractor:** Japan Steel Works**Location:** Muroran, Japan**CWI Name:** Chung Kuan**CWI Present:** Yes No**Inspected CWI report:** Yes No N/A**Rod Oven in Use:** Yes No N/A**Electrode to specification:** Yes No N/A**Weld Procedures Followed:** Yes No N/A**Qualified Welders:** Yes No N/A**Verified Joint Fit-up:** Yes No N/A**Approved Drawings:** Yes No N/A**Approved WPS:** Yes No N/A**Delayed / Cancelled:** Yes No N/A**Bridge No:** 34-0006**Component:** Tower, Jacking and Deviation Saddles**Summary of Items Observed:**

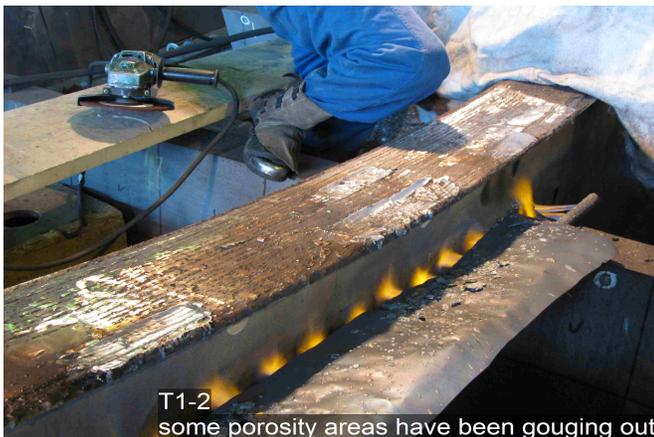
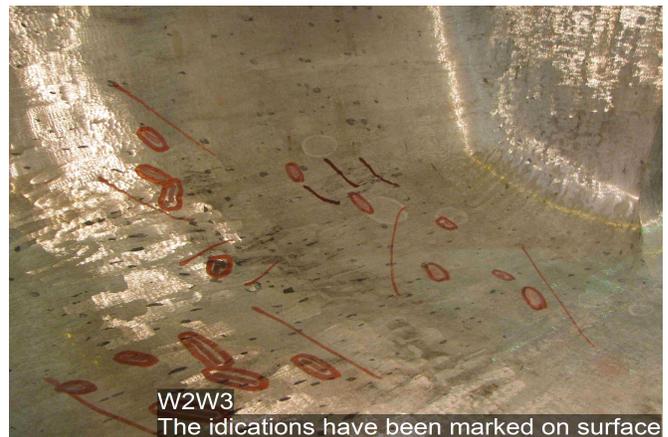
W2W2 and W2W1 West Deviation Saddle casting: Caltrans QAI observed NIS NDT level II technicians perform straight beam UT test on rib side of W2W2 and W2W3 West Deviation Saddles. The thickness of saddle segment is from 150mm to 500mm and both saddle test surface have been Magnetic Particle Test (MT) prior UT test. The straight beam tests have not been completed today and continue tomorrow. Based on Caltrans observations, no discrepancies were noted.

W2W1 West Deviation Saddle casting: Caltrans QAI observed NIS NDT level II technicians perform Liquid Penetrant (PT) on W2W1 west deviation saddle casting rib side surface after grinding. The PT test is not required by Caltrans, JSW used PT test for in house quality assurance. The test surface was free of oil, grease, water, or other contaminants prior PT test. First, two technicians apply the red penetrant by spraying and brushing the saddle surface in a penetrant bath. Next, the penetrant is left on the surface for a sufficient time (dwell times) to allow as much penetrant as possible to be drawn into a defect. Then, the excess penetrant has been removed from the surface of the saddle. Finally, a thin layer of developer is then applied to the saddle by spraying to draw penetrant trapped in flaws back to the surface where it will be visible. Numerous indications have been found on the surface after PT test. All of indications have been marked and wait for MT and UT test for future evaluation. Based on Caltrans observations, no discrepancies were noted.
