DEPARTMENT OF TRANSPORTATION

Contract #: 04-0120F4Cty: SF/ALA Rte: 80 PM: 13.2/13.9File #: 13.28**WELDING INSPECTION REPORT****Resident Engineer:** Pursell, Gary**Address:** 333 Burma Road**City:** Oakland, CA 94607**Report No:** WIR-005389**Date Inspected:** 09-Feb-2009**Project Name:** SAS Superstructure**OSM Arrival Time:** 630**Prime Contractor:** American Bridge/Fluor Enterprises, a JV**OSM Departure Time:** 1700**Contractor:** Oregon Iron Works Clackamas, Or.**Location:** Clackamas, Oregon**CWI Name:** See below**CWI Present:** Yes No**Inspected CWI report:** Yes No N/A**Rod Oven in Use:** Yes No N/A**Electrode to specification:** Yes No N/A**Weld Procedures Followed:** Yes No N/A**Qualified Welders:** Yes No N/A**Verified Joint Fit-up:** Yes No N/A**Approved Drawings:** Yes No N/A**Approved WPS:** Yes No N/A**Delayed / Cancelled:** Yes No N/A**Bridge No:** 34-0006**Component:** Hinge K Pipe Beams**Summary of Items Observed:**

WELDING INSPECTION REPORT

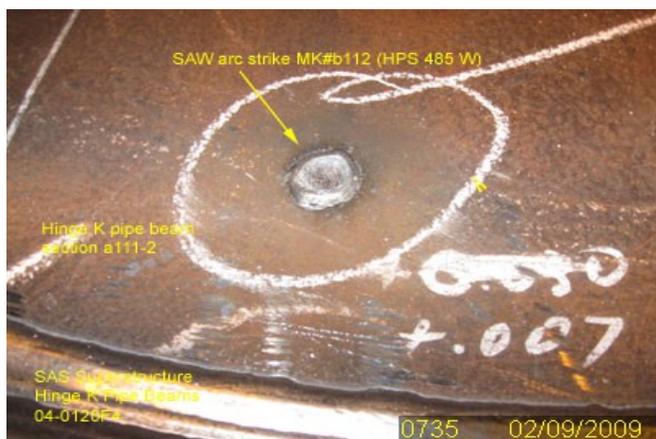
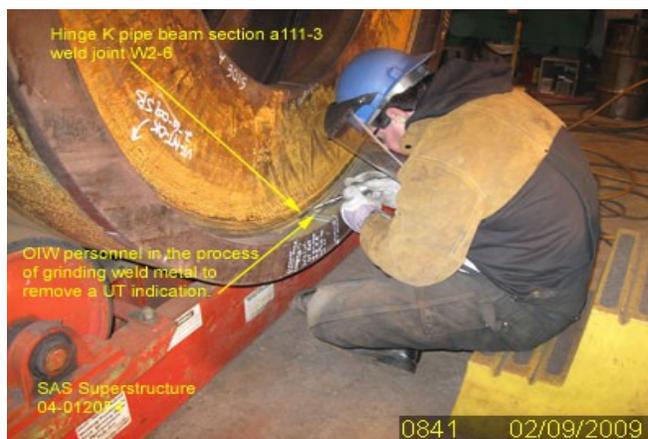
The following digital photograph below illustrates observation of the activities being performed.
