**DEPARTMENT OF TRANSPORTATION**

Contract #: 04-0120F4Cty: SF/ALA Rte: 80 PM: 13.2/13.9File #: 69.28**WELDING INSPECTION REPORT****Resident Engineer:** Pursell, Gary**Address:** 333 Burma Road**City:** Oakland, CA 94607**Report No:** WIR-005399**Date Inspected:** 06-Feb-2009**Project Name:** SAS Superstructure**OSM Arrival Time:** 645**Prime Contractor:** American Bridge/Fluor Enterprises, a JV**OSM Departure Time:** 1845**Contractor:** Zhenhua Port Machinery Company, Ltd (ZPMC), Changxing Island **Location:** Shanghai, China**CWI Name:** See Below**CWI Present:** Yes No**Inspected CWI report:** Yes No N/A**Rod Oven in Use:** Yes No N/A**Electrode to specification:** Yes No N/A**Weld Procedures Followed:** Yes No N/A**Qualified Welders:** Yes No N/A**Verified Joint Fit-up:** Yes No N/A**Approved Drawings:** Yes No N/A**Approved WPS:** Yes No N/A**Delayed / Cancelled:** Yes No N/A**Bridge No:** 34-0006**Component:** OBG Fabrication**Summary of Items Observed:**

**OBG Bay 3**

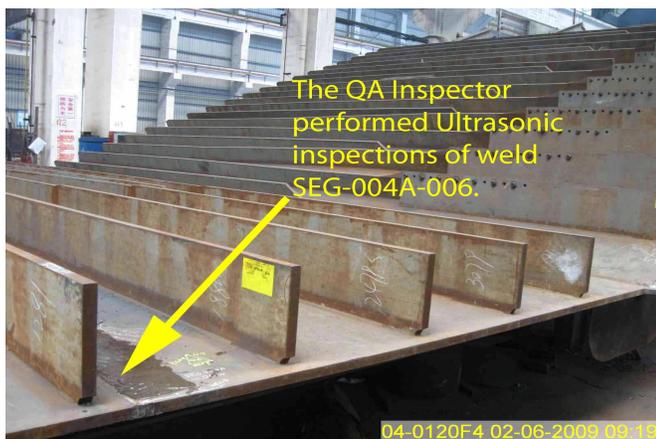
This QA Inspector performed random ultrasonic (UT) inspections of OBG weld SEG-004A-006. This butt weld joins baseplate BP312A to BP310A. This weld is listed on ZPMC Notification of Witness Inspection document 001925. The QA Inspector observed the weld that was ultrasonically inspected by this QA Inspector appears to comply with AWS D1.5 UT requirements. For additional information on this inspection see the TL6027 Ultrasonic Test Report and the photograph below.
