**DEPARTMENT OF TRANSPORTATION**

Contract #: 04-0120F4Cty: SF/ALA Rte: 80 PM: 13.2/13.9File #: 69.28**WELDING INSPECTION REPORT****Resident Engineer:** Pursell, Gary**Address:** 333 Burma Road**City:** Oakland, CA 94607**Report No:** WIR-005490**Date Inspected:** 22-Feb-2009**Project Name:** SAS Superstructure**OSM Arrival Time:** 700**Prime Contractor:** American Bridge/Fluor Enterprises, a JV**OSM Departure Time:** 1900**Contractor:** Zhenhua Port Machinery Company, Ltd (ZPMC), Changxing Island **Location:** Shanghai China**CWI Name:** Zhu Zhong Hai**CWI Present:** Yes No**Inspected CWI report:** Yes No N/A**Rod Oven in Use:** Yes No N/A**Electrode to specification:** Yes No N/A**Weld Procedures Followed:** Yes No N/A**Qualified Welders:** Yes No N/A**Verified Joint Fit-up:** Yes No N/A**Approved Drawings:** Yes No N/A**Approved WPS:** Yes No N/A**Delayed / Cancelled:** Yes No N/A**Bridge No:** 34-0006**Component:** OBG cross beams**Summary of Items Observed:**

OBG bay 19

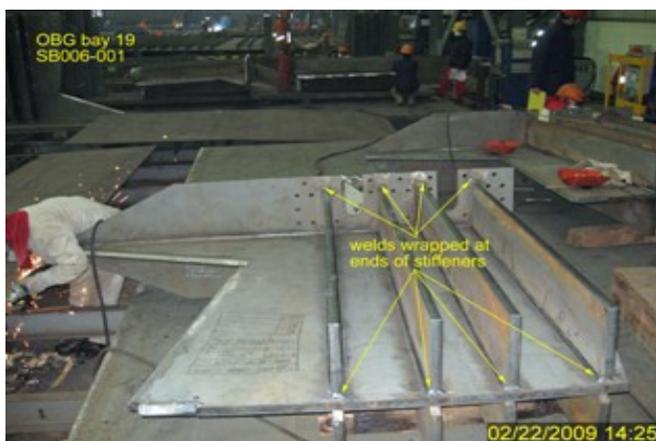
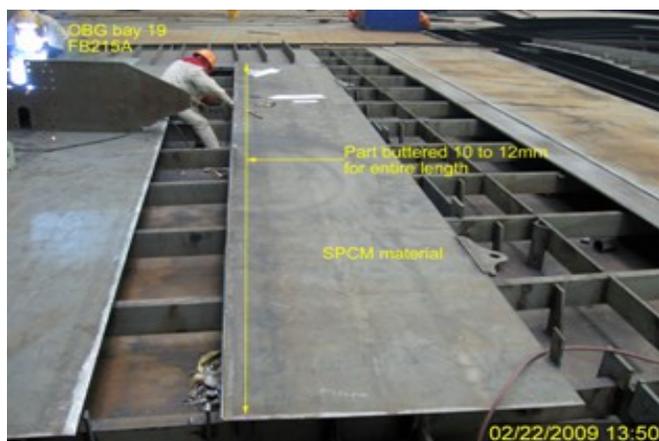
This QA observed ZPMC qualified welding personnel buttering the edge of floor beam component identified on the material as FB215A. QA noted that the material was marked as SPCM material. This QA spoke with ABF QA inspector identified as Mr. Kelvin Cheung concerning the reason this plate was being buttered. Mr. Cheung contacted ZPMC QC CWI identified as Mr. Zhu Zhong Hai who produced a weld repair report identified as weld repair report no. B-WR2466. The report indicated that the part was 10mm too narrow and was buttered 10mm to 12mm along the entire edge of the plate (approximately 6m to 7m in length). This QA informed both ZPMC QC and ABF QA inspectors that due to the fact that the material was classified as SPCM and the buttering exceeded  $\frac{1}{4}$  of the thickness of the material (12mm) a Critical Weld Repair CWR was needed to perform this repair as specified in AWS D1.5 2002 section 12.17.2 (7). ZPMC QC informed this QA that a CWR had not been submitted to the engineer for approval prior to beginning the repair. This QA informed ZPMC QC and ABF QA that an incident report would be issued for this non compliance. See attached photos.

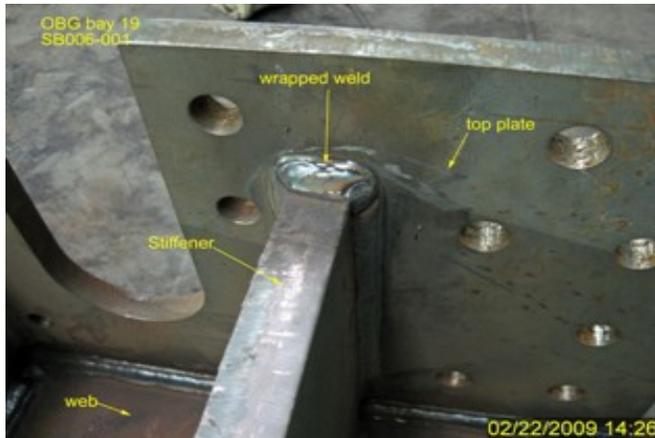
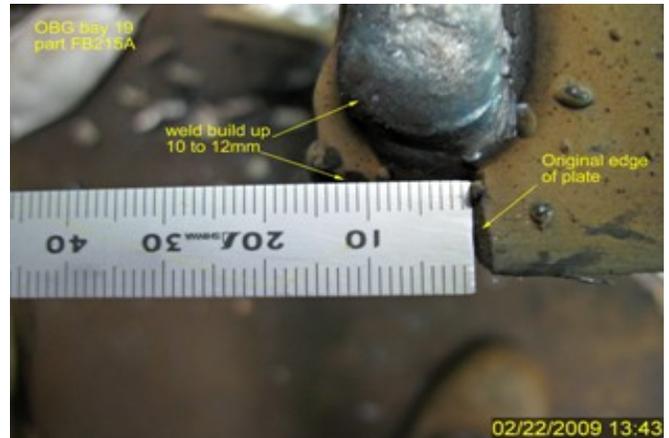
This QA observed ZPMC welding personnel were wrapping the welds around the ends of the stiffeners on the suspension brackets. This QA informed ZPMC QC CWI identified as Mr. Zhu Zhong Hai and ABF QA identified as Mr. Kelvin Cheung of this non compliance to the drawings. General notes drawing GN3 detail WT1 specifies a typical weld termination for all stiffener welds. The detail indicates the weld be terminated at or near the end of the joint without wrapping the end. QA has issued an incident report for this non compliance. See attached photos.
