DEPARTMENT OF TRANSPORTATION

Contract #: 04-0120F4Cty: SF/ALA Rte: 80 PM: 13.2/13.9File #: 69.28**WELDING INSPECTION REPORT****Resident Engineer:** Pursell, Gary**Address:** 333 Burma Road**City:** Oakland, CA 94607**Report No:** WIR-005592**Date Inspected:** 25-Feb-2009**Project Name:** SAS Superstructure**OSM Arrival Time:** 1845**Prime Contractor:** American Bridge/Fluor Enterprises, a JV**OSM Departure Time:** 645**Contractor:** Zhenhua Port Machinery Company, Ltd (ZPMC), Changxing Island **Location:** Shanghai, China

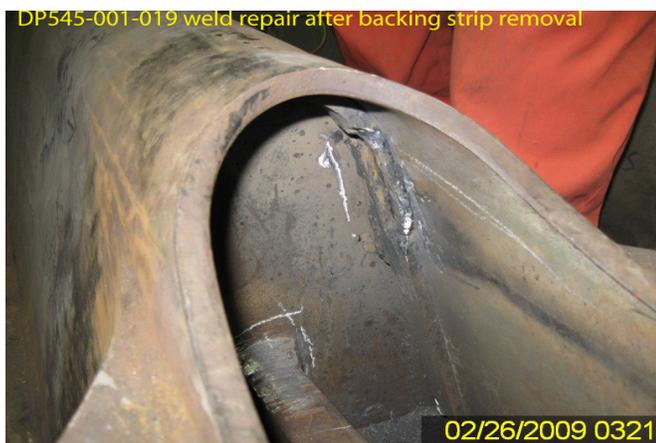
QA inspector observed the backing bar had been removed from U-rib weld and repair was performed from the interior of the U-rib on DP545-001-019. The interior of the weld was visually unacceptable with excessive reinforcement and cold lap observed. ZPMC did not have a posted welding procedure for this repair. The above mentioned information was passed on to day shift. Please see the attached photo below of DP545-001-019. No ZPMC certified welding inspector was present as there were no welding being performed. This information was passed on to ZPMC QC Lei Tao.
