**DEPARTMENT OF TRANSPORTATION**

Contract #: 04-0120F4Cty: SF/ALA Rte: 80 PM: 13.2/13.9File #: 13.28**WELDING INSPECTION REPORT****Resident Engineer:** Pursell, Gary**Address:** 333 Burma Road**City:** Oakland, CA 94607**Report No:** WIR-005618**Date Inspected:** 03-Mar-2009**Project Name:** SAS Superstructure**OSM Arrival Time:** 630**Prime Contractor:** American Bridge/Fluor Enterprises, a JV**OSM Departure Time:** 1600**Contractor:** Oregon Iron Works Clackamas, Or.**Location:** Clackamas, Oregon**CWI Name:** See below**CWI Present:** Yes No**Inspected CWI report:** Yes No N/A**Rod Oven in Use:** Yes No N/A**Electrode to specification:** Yes No N/A**Weld Procedures Followed:** Yes No N/A**Qualified Welders:** Yes No N/A**Verified Joint Fit-up:** Yes No N/A**Approved Drawings:** Yes No N/A**Approved WPS:** Yes No N/A**Delayed / Cancelled:** Yes No N/A**Bridge No:** 34-0006**Component:** Hinge K Pipe Beams**Summary of Items Observed:**

## WELDING INSPECTION REPORT

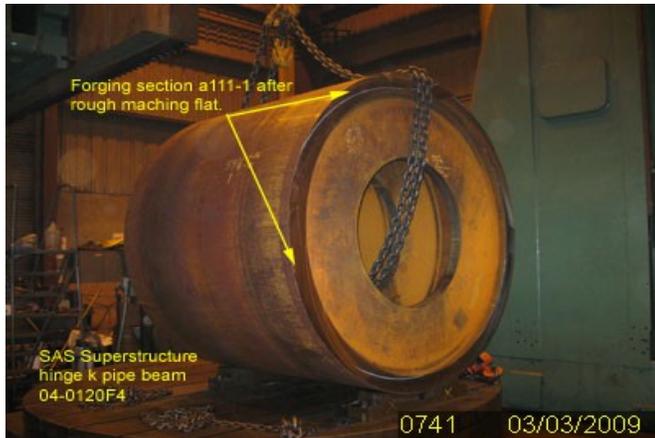
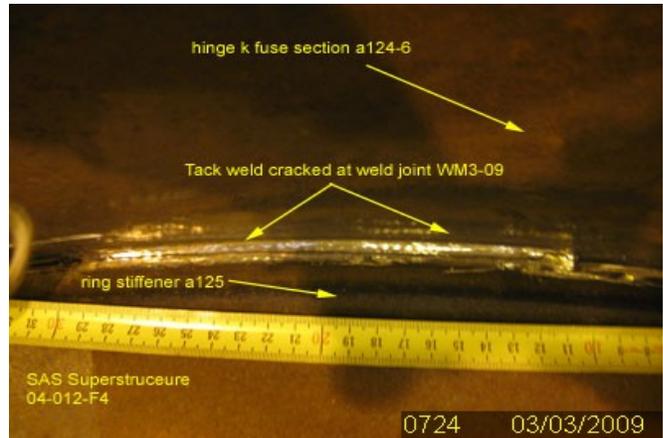
The following digital photograph below illustrates observation of the activities being performed.
