**DEPARTMENT OF TRANSPORTATION**

Contract #: 04-0120F4Cty: SF/ALA Rte: 80 PM: 13.2/13.9File #: 69.28**WELDING INSPECTION REPORT****Resident Engineer:** Pursell, Gary**Address:** 333 Burma Road**City:** Oakland, CA 94607**Report No:** WIR-005710**Date Inspected:** 05-Mar-2009**Project Name:** SAS Superstructure**OSM Arrival Time:** 645**Prime Contractor:** American Bridge/Fluor Enterprises, a JV**OSM Departure Time:** 1845**Contractor:** Zhenhua Port Machinery Company, Ltd (ZPMC), Changxing Island **Location:** Shanghai, China

# WELDING INSPECTION REPORT

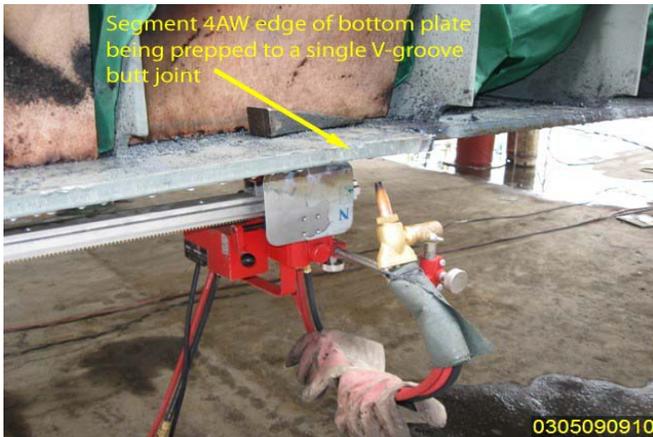
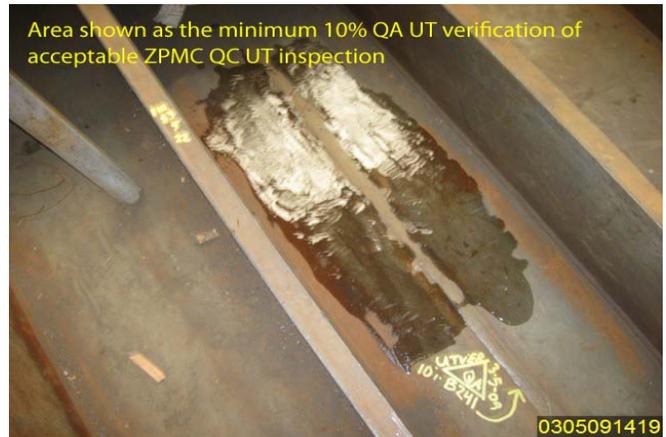
Segment 4AW: QA Inspector observed ZPMC personnel prepping the edge of bottom plates on segment 4AW using the oxy-acetylene cutting process. ZPMC QC Inspector informed QA Inspector that the joint edge prep was cut to AWS D1.5 (02) single V groove butt joint requirements. QA Inspector discussed with QC Inspector that the bevel angle of the edge prep needed to be ground at various locations due to remaining slag from cutting process and gouges in bevel edge.
