**DEPARTMENT OF TRANSPORTATION**

Contract #: 04-0120F4Cty: SF/ALA Rte: 80 PM: 13.2/13.9File #: 69.28**WELDING INSPECTION REPORT****Resident Engineer:** Pursell, Gary**Address:** 333 Burma Road**City:** Oakland, CA 94607**Report No:** WIR-006085**Date Inspected:** 27-Feb-2009**Project Name:** SAS Superstructure**OSM Arrival Time:** 645**Prime Contractor:** American Bridge/Fluor Enterprises, a JV**OSM Departure Time:** 1845**Contractor:** Zhenhua Port Machinery Company, Ltd (ZPMC), Changxing Island **Location:** Shanghai, China**CWI Name:** See Below**CWI Present:** Yes No**Inspected CWI report:** Yes No N/A**Rod Oven in Use:** Yes No N/A**Electrode to specification:** Yes No N/A**Weld Procedures Followed:** Yes No N/A**Qualified Welders:** Yes No N/A**Verified Joint Fit-up:** Yes No N/A**Approved Drawings:** Yes No N/A**Approved WPS:** Yes No N/A**Delayed / Cancelled:** Yes No N/A**Bridge No:** 34-0006**Component:** Tower Fabrication**Summary of Items Observed:**

# WELDING INSPECTION REPORT

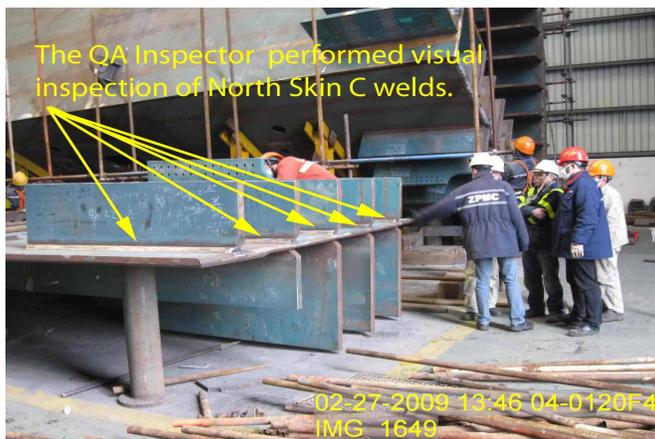
ZPMC QC representative Mr. Ken Zhang requested Caltrans QA personnel to perform final visual inspection of north tower, lift 1 skin plate C bearing plate welds NSD1-SA22A/E -10, -12, -16, -18, -22, -25, -26, -38, -42 and -43. The QA Inspector observed the weld radius at the bottom end of welds NSD1-SA22-B/E-10 and NSD1-SA22-B/E-38 have irregular shaped radiuses instead of smoothly ground radiuses. The QA Inspector informed Mr. Zhang the radius of these two welds do not appear to comply with project specifications and after the welds were ground to a radius shape, the QA Inspector observed all ten welds appear to comply with project specifications. See the photograph below for additional information.
