DEPARTMENT OF TRANSPORTATION

Contract #: 04-0120F4Cty: SF/ALA Rte: 80 PM: 13.2/13.9File #: 69.28**WELDING INSPECTION REPORT****Resident Engineer:** Pursell, Gary**Address:** 333 Burma Road**City:** Oakland, CA 94607**Report No:** WIR-006092**Date Inspected:** 07-Mar-2009**Project Name:** SAS Superstructure**OSM Arrival Time:** 645**Prime Contractor:** American Bridge/Fluor Enterprises, a JV**OSM Departure Time:** 1845**Contractor:** Zhenhua Port Machinery Company, Ltd (ZPMC), Changxing Island **Location:** Shanghai, China**CWI Name:** See Below**CWI Present:** Yes No**Inspected CWI report:** Yes No N/A**Rod Oven in Use:** Yes No N/A**Electrode to specification:** Yes No N/A**Weld Procedures Followed:** Yes No N/A**Qualified Welders:** Yes No N/A**Verified Joint Fit-up:** Yes No N/A**Approved Drawings:** Yes No N/A**Approved WPS:** Yes No N/A**Delayed / Cancelled:** Yes No N/A**Bridge No:** 34-0006**Component:** Tower Fabrication**Summary of Items Observed:**

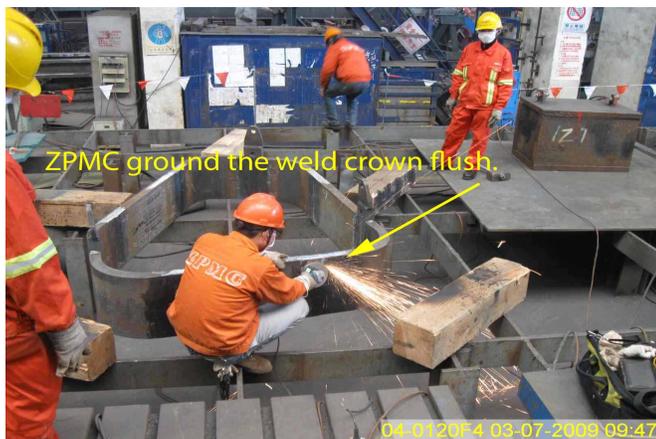
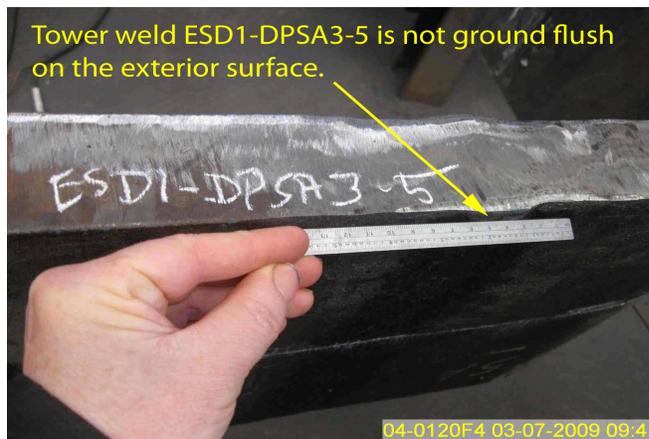
This QA Inspector performed random visual inspection of tower diaphragm weld ESD1-DPSA3-18-5 and observed that the exterior top end of the weld has a weld reinforcement of approximately 3 mm. The design drawing for this weld requires the weld to be flush on the exterior surface. The QA Inspector informed ZPMC CWI Mr. Liu Huanije that this weld does not appear to be flush on the upper end. Mr. Liu Huanije said another CWI had visually inspected these welds and that he will have the weld ground to a flush condition. Following completion of the grinding flush of weld #5, this QA Inspector performed random ultrasonic (UT) inspections of approximately 10 percent length of tower diaphragm welds WSD1-SA360-E/F-4, WSD1-SA360-D/F-17 and WSD1-SA360-D/F-20. These welds had previously been ultrasonically inspected and accepted by ZPMC inspection personnel and the welds are listed on ZPMC Notification of Witness Inspection document 002178. The QA Inspector observed the welds that were ultrasonically inspected by this QA Inspector appear to comply with AWS D1.5 UT requirements. For additional information on this inspection see the TL6027 Ultrasonic Test Report and the photographs below.
