**DEPARTMENT OF TRANSPORTATION**

Contract #: 04-0120F4Cty: SF/ALA Rte: 80 PM: 13.2/13.9File #: 69.28**WELDING INSPECTION REPORT****Resident Engineer:** Pursell, Gary**Address:** 333 Burma Road**City:** Oakland, CA 94607**Report No:** WIR-006098**Date Inspected:** 14-Mar-2009**Project Name:** SAS Superstructure**OSM Arrival Time:** 645**Prime Contractor:** American Bridge/Fluor Enterprises, a JV**OSM Departure Time:** 1845**Contractor:** Zhenhua Port Machinery Company, Ltd (ZPMC), Changxing Island **Location:** Shanghai, China**CWI Name:** See Below**CWI Present:** Yes No**Inspected CWI report:** Yes No N/A**Rod Oven in Use:** Yes No N/A**Electrode to specification:** Yes No N/A**Weld Procedures Followed:** Yes No N/A**Qualified Welders:** Yes No N/A**Verified Joint Fit-up:** Yes No N/A**Approved Drawings:** Yes No N/A**Approved WPS:** Yes No N/A**Delayed / Cancelled:** Yes No N/A**Bridge No:** 34-0006**Component:** Tower Fabrication**Summary of Items Observed:**

## Tower Bay 10

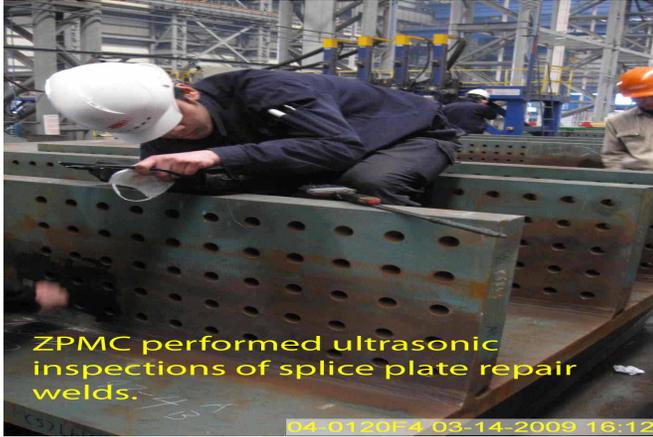
At around 1000 hours ZPMC QC representative Mr. (Tom) Li Xiu Yang requested Caltrans QA personnel to perform final visual inspection of lift 1 South Skin tower splice plate stiffener to baseplate welds SSD1-SA097 -1, -2, -3, -4; SSD1-SA106, -1, -2, -3, -4, -5; SSD1-SA108 -1, -2, -3, -4; and SSD1-SA109-1, -2, -3 for the purpose of issuing green tag releases. The QA Inspector performed random visual inspections of the stiffener to connection plate welds and observed the top toe of connection plate SSD1-SA108 weld #4 has a grind area that is approximately 2 mm below the surface of the adjacent base material, and weld SSD-SA97 has a 2mm diameter pit of unknown depth in the face of the weld. The QA Inspector informed ZPMC CWI Mr. Liu Yang of the below flush and pit problems and Mr. Yang said these areas will be weld repaired. At around 1530 hours Mr. Yang informed the QA Inspector that all weld repairs have been completed and the connection plates are ready for green tagging. The QA Inspector informed Mr. Yang that both of the weld repairs need to be ultrasonically inspected prior to issuance of green tags. The QA Inspector witnessed ZPMC ultrasonic Inspectors performing ultrasonic inspections of these two weld repair areas. See the photograph below showing ZPMC performing ultrasonic

inspections of the repair weld. ABF representative Mr. Kim presented green tag release documents for the welds on each of the connection plates. Following ABF and ZPMC signatures the QA Inspector indicated Caltrans concurrence by placing lot number B254 on each of the four documents. Green tag #5601 was issued for South Skin A splice plate SSD1-SA097 welds -1, -2, -3,-4; green tag # 5602 was issued South Skin C for splice plate SSD1-SA106 welds -1, -2, -3, -4,-5; green tag # 2578 was issued for South Skin E splice plate SSD1-SA108 welds -1, -2, -3, -4; and green tag # 5603 was issued for South Skin B splice plate SSD1-SA109 welds -1, -2, -3.
