DEPARTMENT OF TRANSPORTATION

Contract #: 04-0120F4Cty: SF/ALA Rte: 80 PM: 13.2/13.9File #: 69.28**WELDING INSPECTION REPORT****Resident Engineer:** Pursell, Gary**Address:** 333 Burma Road**City:** Oakland, CA 94607**Report No:** WIR-006099**Date Inspected:** 15-Mar-2009**Project Name:** SAS Superstructure**OSM Arrival Time:** 645**Prime Contractor:** American Bridge/Fluor Enterprises, a JV**OSM Departure Time:** 1845**Contractor:** Zhenhua Port Machinery Company, Ltd (ZPMC), Changxing Island **Location:** Shanghai, China**CWI Name:** See Below**CWI Present:** Yes No**Inspected CWI report:** Yes No N/A**Rod Oven in Use:** Yes No N/A**Electrode to specification:** Yes No N/A**Weld Procedures Followed:** Yes No N/A**Qualified Welders:** Yes No N/A**Verified Joint Fit-up:** Yes No N/A**Approved Drawings:** Yes No N/A**Approved WPS:** Yes No N/A**Delayed / Cancelled:** Yes No N/A**Bridge No:** 34-0006**Component:** Tower Fabrication**Summary of Items Observed:**

Tower Bay 10

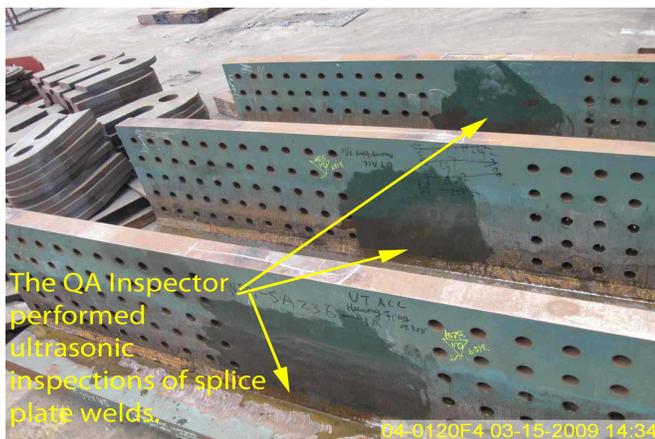
This QA Inspector performed random ultrasonic inspections of approximately 10 percent length of Lift 1 South Skin Interior Splice Plate welds WSD1-SA097-1, WSD1-SA218-1, WSD1-SA218-2, WSD1-SA218-3, WSD1-SA218-4, WSD1-SA236-1, WSD1-SA236-2, WSD1-SA236-3, WSD1-SA103-4 and WSD1-SA103-5. These welds had previously been ultrasonically inspected and accepted by ZPMC inspection personnel. ZPMC ultrasonic inspectors have rejected the remaining welds on these Lift 1 South Skin Interior Connection Splice plates. The QA Inspector observed the welds that were ultrasonically inspected by this QA Inspector appear to comply with AWS D1.5 UT requirements. For additional information on this inspection see the TL6027 Ultrasonic Test Report and the photograph below.
