DEPARTMENT OF TRANSPORTATION

Contract #: 04-0120F4Cty: SF/ALA Rte: 80 PM: 13.2/13.9File #: 69.28**WELDING INSPECTION REPORT****Resident Engineer:** Pursell, Gary**Address:** 333 Burma Road**City:** Oakland, CA 94607**Report No:** WIR-006198**Date Inspected:** 06-Apr-2009**Project Name:** SAS Superstructure**OSM Arrival Time:** 700**Prime Contractor:** American Bridge/Fluor Enterprises, a JV**OSM Departure Time:** 1900**Contractor:** Zhenhua Port Machinery Company, Ltd (ZPMC), Changxing Island **Location:** Shanghai, China**CWI Name:** Xu Tao**CWI Present:** Yes No**Inspected CWI report:** Yes No N/A**Rod Oven in Use:** Yes No N/A**Electrode to specification:** Yes No N/A**Weld Procedures Followed:** Yes No N/A**Qualified Welders:** Yes No N/A**Verified Joint Fit-up:** Yes No N/A**Approved Drawings:** Yes No N/A**Approved WPS:** Yes No N/A**Delayed / Cancelled:** Yes No N/A**Bridge No:** 34-0006**Component:** OBG crossbeams**Summary of Items Observed:**

WELDING INSPECTION REPORT

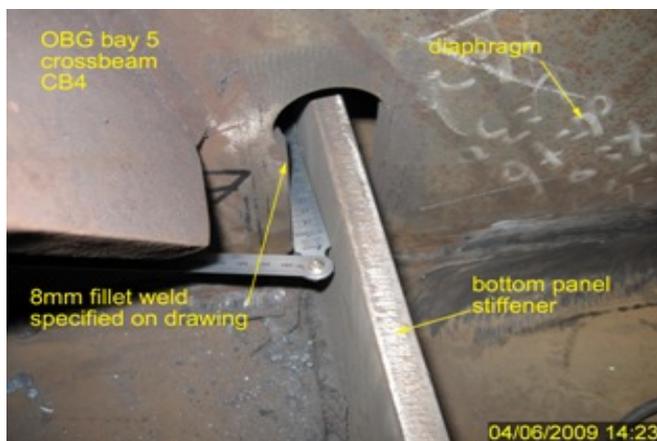
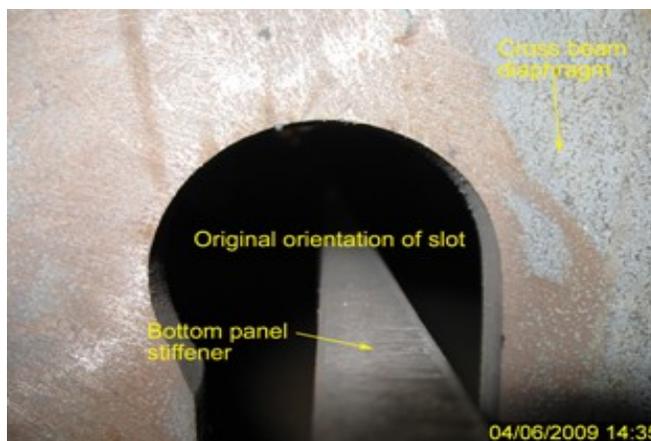
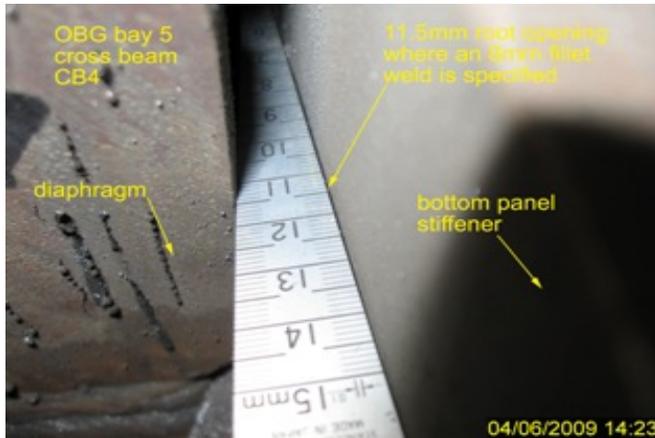
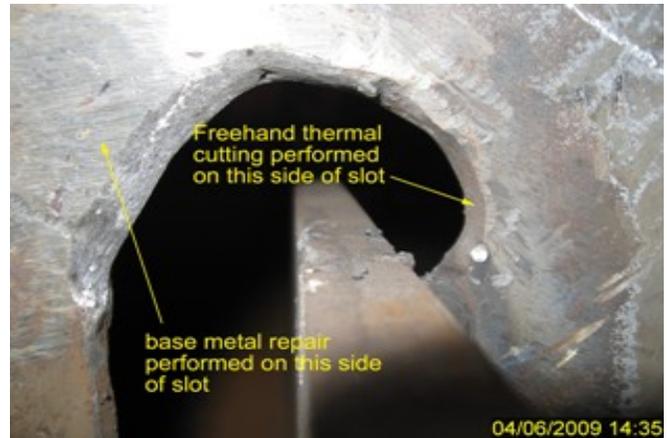
QA observed ZPMC personnel fitting and welding cross beam identified as CB4 in this bay. QA observed numerous weld joints with excessive root openings. These root openings range from 5mm to 11mm. The joints in question are where the bottom panel and side panel stiffeners pass through the clearance slots cut in the four intermediate diaphragms. See attached photos for details. These joints have not yet been welded. This QA has brought this issue to the attention of ZPMC QA identified as Mr. Lei Tau and ABF QA inspector identified as Mr. Kelvin Cheung. ZPMC and ABF informed this QA that they would look into this issue and propose a solution prior to completing the welds on these joints.

This QA observed that the contractor has performed free hand thermal cutting on the stiffener clearance slots on the above mentioned cross beam diaphragms and performed base metal weld repairs in order to reverse the direction of the opening at the tops of the slots without the engineers approval. This condition exists at three locations on each of the four floorbeams in this crossbeam. See attached photos for details. This QA has brought this issue to the attention of ZPMC QA identified as Mr. Lei Tau and ABF QA inspector identified as Mr. Kelvin Cheung and informed both of them that an incident report will be issued for this non-conformance.
