DEPARTMENT OF TRANSPORTATION

OBG outside assembly 4AW and 4BW

OBG outside assembly 4BE, 3AE and 3BE

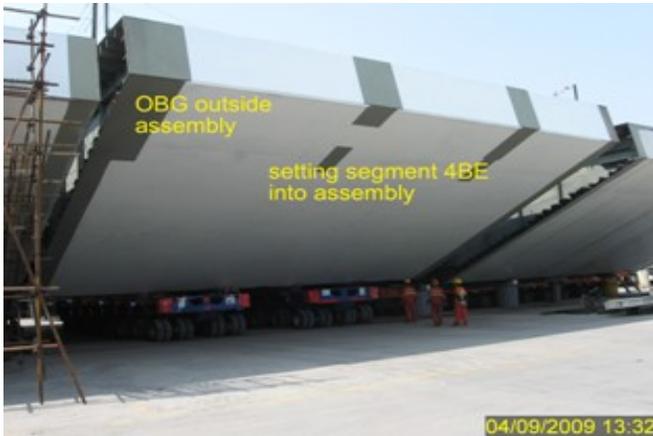
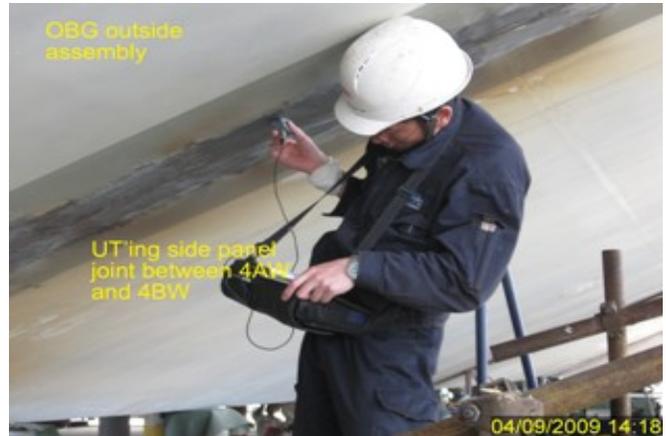
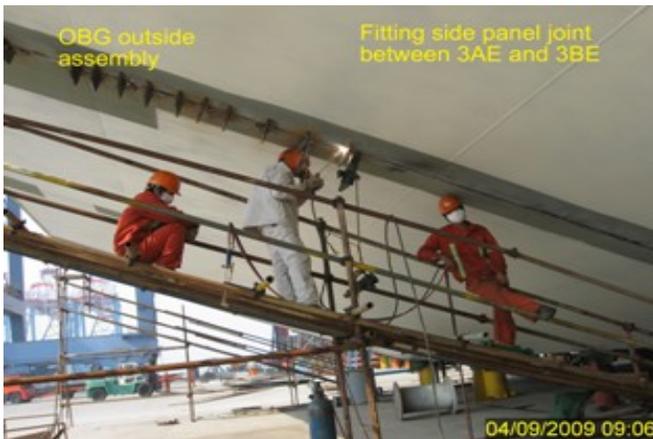
This QA observed ZPMC qualified welding personnel identified as 220064 and 220067 perform FCAW welding at the ends of the T-Ribs that were left unwelded in order to facilitate stiffener alignment at assembly. ZPMC QC identified as Mr. Zhang Hai Tao was present to monitor the welding process. The welding parameters as measured using QC's calibrated instruments appeared to be in general compliance with WPS-B-T-2233-B-U2-F.

This QA observed ZPMC QC Non-Destructive Testing (NDT) sub-contractor performing Ultrasonic Testing (UT) at the splice joint between 4AW and 4BW. QA observed that QC has completed the UT on the bottom panel splice and appears to have rejected 48 indications on this joint. QC has not completed UT of the side panels or the deck panel at this time.

This QA observed ZPMC personnel fitting and tack welding the splice joint between 3AE and 3BE. The edge plates appear to be 100% fit, side panels approximately 75% complete, deck panel approximately 50% complete

This QA observed ZPMC personnel welding stiffeners to the underside of deck panel on 3AE in the area of the cross beam where the deck plate cantilevers over the edge plate.

This QA observed ZPMC personnel moving segment 4BE into its position on the east bound segment assembly.
