**DEPARTMENT OF TRANSPORTATION**

Contract #: 04-0120F4Cty: SF/ALA Rte: 80 PM: 13.2/13.9File #: 69.28**WELDING INSPECTION REPORT****Resident Engineer:** Pursell, Gary**Address:** 333 Burma Road**City:** Oakland, CA 94607**Report No:** WIR-006296**Date Inspected:** 17-Apr-2009**Project Name:** SAS Superstructure**OSM Arrival Time:** 1845**Prime Contractor:** American Bridge/Fluor Enterprises, a JV**OSM Departure Time:** 645**Contractor:** Zhenhua Port Machinery Company, Ltd (ZPMC), Changxing Island **Location:** Shanghai, China**CWI Name:** See Below**CWI Present:** Yes No**Inspected CWI report:** Yes No N/A**Rod Oven in Use:** Yes No N/A**Electrode to specification:** Yes No N/A**Weld Procedures Followed:** Yes No N/A**Qualified Welders:** Yes No N/A**Verified Joint Fit-up:** Yes No N/A**Approved Drawings:** Yes No N/A**Approved WPS:** Yes No N/A**Delayed / Cancelled:** Yes No N/A**Bridge No:** 34-0006**Component:** Tower Fabrication**Summary of Items Observed:**

## WELDING INSPECTION REPORT

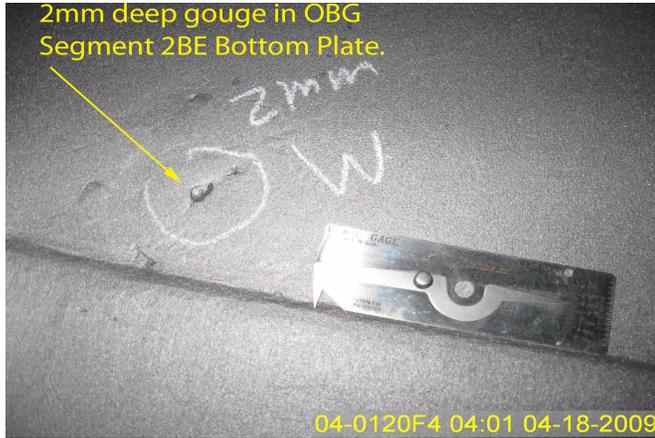
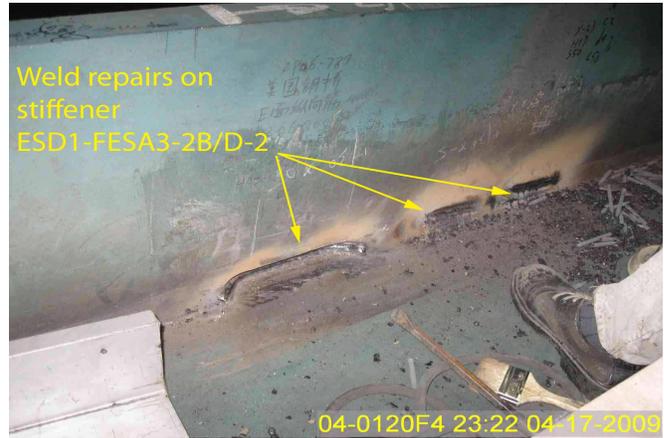
This QA Inspector along with QA Inspector Mr. Larry Viars performed preliminary random visual inspection of OBG segment 2BE bottom plate and adjacent welds following initial grit blasting. The QA Inspector observed one weld that has a 3mm diameter porosity pit near the center of the weld and at another location there are base material pits that appear to be located where a temporary alignment plate weld had been removed adjacent to a CJP butt weld. The locations of these visual rejections have been documented on a QA "Preliminary Inspection" drawing that will be used during followup inspections by QA personnel. The inspections were limited due to a short window of time that these surfaces were available, between grit blasting events. See the photograph below showing the base material pits.
