DEPARTMENT OF TRANSPORTATION

Contract #: 04-0120F4Cty: SF/ALA Rte: 80 PM: 13.2/13.9File #: 69.28**WELDING INSPECTION REPORT****Resident Engineer:** Pursell, Gary**Address:** 333 Burma Road**City:** Oakland, CA 94607**Report No:** WIR-006392**Date Inspected:** 08-Apr-2009**Project Name:** SAS Superstructure**OSM Arrival Time:** 1845**Prime Contractor:** American Bridge/Fluor Enterprises, a JV**OSM Departure Time:** 645**Contractor:** Zhenhua Port Machinery Company, Ltd (ZPMC), Changxing Island **Location:** Shanghai, China**CWI Name:** Liu Liang**CWI Present:** Yes No**Inspected CWI report:** Yes No N/A**Rod Oven in Use:** Yes No N/A**Electrode to specification:** Yes No N/A**Weld Procedures Followed:** Yes No N/A**Qualified Welders:** Yes No N/A**Verified Joint Fit-up:** Yes No N/A**Approved Drawings:** Yes No N/A**Approved WPS:** Yes No N/A**Delayed / Cancelled:** Yes No N/A**Bridge No:** 34-0006**Component:** Tower**Summary of Items Observed:**

WELDING INSPECTION REPORT

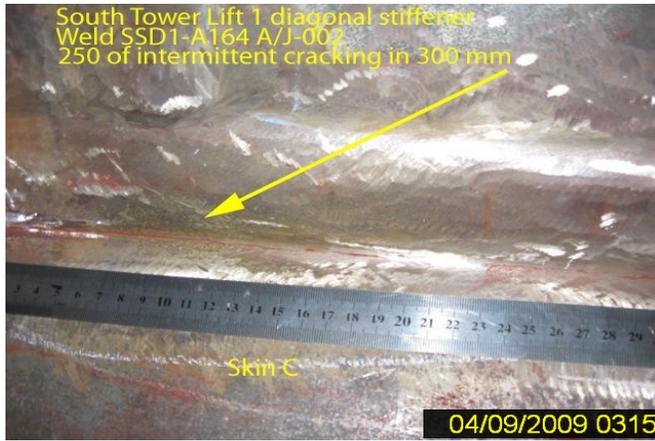
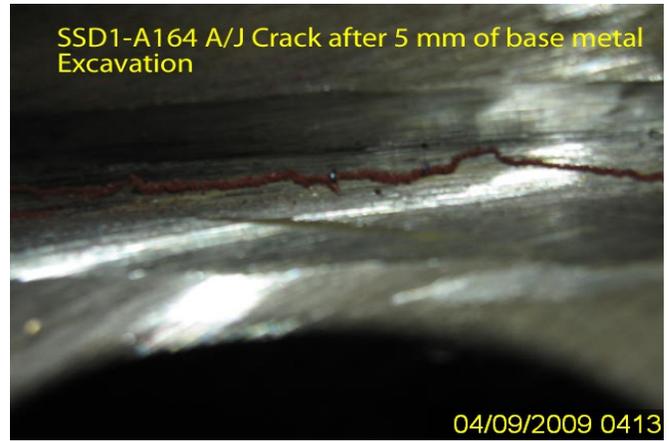
This QA inspector received NDT Inspection Notification Sheet 002576 for Quality Assurance verification of Visual Testing (VT), Magnetic Particle Testing (MT) of South Tower Lift 1 (Skin C to D) Diagonal stiffeners. QA performed Visual inspection of welds and performed MT. During MT inspection intermittent cracking (250 of 300 mm) was found on weld SSD1-A164 A/J-002. ZPMC QC stated that MT had not been performed by ZPMC MT. ZPMC personnel removed approximately 5 mm of base metal and cracks were still present. ZPMC QC stated that MT would be performed on the remainder of welds and that a critical weld repair report would be submitted for approval prior to weld repair. Please see the attached photos below of the above mentioned Tower crack. Testing results were submitted to Caltrans Quality Assurance Lead inspector Mr. William Clifford.

This QA Inspector observed the following work in progress: FCAW welding of weld joint 146 and 147 located on Tower component NSD1-TL8E-L. ZPMC welder was identified as Jia Quan. ZPMC QC is identified as Liu liang. The welding appeared to be in conformance with welding procedure specification, WPS-B-T-4132
