**DEPARTMENT OF TRANSPORTATION**

Contract #: 04-0120F4Cty: SF/ALA Rte: 80 PM: 13.2/13.9File #: 69.28**WELDING INSPECTION REPORT****Resident Engineer:** Pursell, Gary**Address:** 333 Burma Road**City:** Oakland, CA 94607**Report No:** WIR-006426**Date Inspected:** 20-Apr-2009**Project Name:** SAS Superstructure**OSM Arrival Time:** 700**Prime Contractor:** American Bridge/Fluor Enterprises, a JV**OSM Departure Time:** 1900**Contractor:** Zhenhua Port Machinery Company, Ltd (ZPMC), Changxing Island **Location:** Shanghai, China

## WELDING INSPECTION REPORT

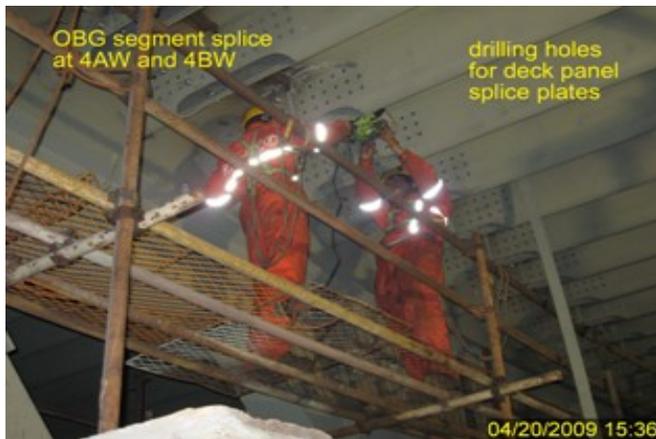
This QA observed contractors personnel performing various tasks relative to the fabrication of the OBG superstructure assembly, including the following: welding, bolting assemblies, hole drilling, grinding and quality control inspection and weld monitoring.

Unless otherwise noted, all work observed on this date appeared to be in general compliance with the applicable contract documents.
