DEPARTMENT OF TRANSPORTATION

Contract #: 04-0120F4Cty: SF/ALA Rte: 80 PM: 13.2/13.9File #: 69.28**WELDING INSPECTION REPORT****Resident Engineer:** Pursell, Gary**Address:** 333 Burma Road**City:** Oakland, CA 94607**Report No:** WIR-006465**Date Inspected:** 19-Apr-2009**Project Name:** SAS Superstructure**OSM Arrival Time:** 1845**Prime Contractor:** American Bridge/Fluor Enterprises, a JV**OSM Departure Time:** 645**Contractor:** Zhenhua Port Machinery Company, Ltd (ZPMC), Changxing Island **Location:** Shanghai, China**CWI Name:** See Below**CWI Present:** Yes No**Inspected CWI report:** Yes No N/A**Rod Oven in Use:** Yes No N/A**Electrode to specification:** Yes No N/A**Weld Procedures Followed:** Yes No N/A**Qualified Welders:** Yes No N/A**Verified Joint Fit-up:** Yes No N/A**Approved Drawings:** Yes No N/A**Approved WPS:** Yes No N/A**Delayed / Cancelled:** Yes No N/A**Bridge No:** 34-0006**Component:** OBG and Tower Fabrication**Summary of Items Observed:**

WELDING INSPECTION REPORT

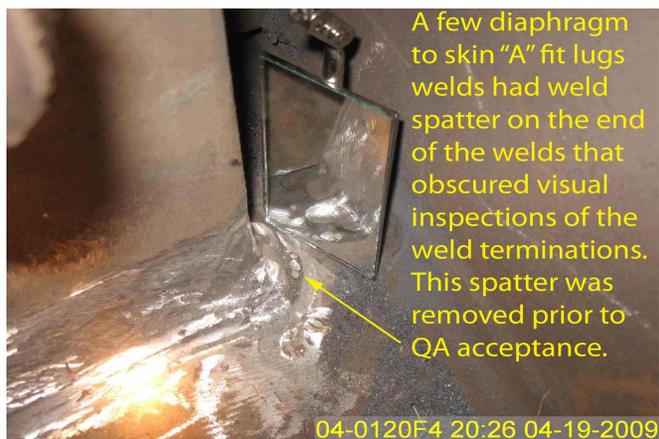
visual inspection of these welds observed a few welds that had rough terminations, and one weld that required additional welding to resolve an underfill condition. The QA Inspector informed ZPMC QC representative Mr. Lay Tau of these weld problems and he had ZPMC personnel complete repairs of these items. Following grinding and welding of the welds the QA Inspector determined the welds listed above appear to comply with project specifications.

Note: ZPMC did not inform this QA Inspector that there were two diaphragm to skin plate welds at each of elevations and this QA Inspector was only presented with the upper diaphragm to skin plate welds for inspections. ABF had not prepared a weld signoff sheet for the diaphragm to skin plate welds. See this QA Inspector's April 21, 2009 TL-6031 Welding Inspection Report for additional information on the inspections of these other welds. See the photograph below for additional information.
