**DEPARTMENT OF TRANSPORTATION**

Contract #: 04-0120F4Cty: SF/ALA Rte: 80 PM: 13.2/13.9File #: 13.28**WELDING INSPECTION REPORT****Resident Engineer:** Pursell, Gary**Address:** 333 Burma Road**City:** Oakland, CA 94607**Report No:** WIR-006548**Date Inspected:** 04-May-2009**Project Name:** SAS Superstructure**OSM Arrival Time:** 700**Prime Contractor:** American Bridge/Fluor Enterprises, a JV**OSM Departure Time:** 1530**Contractor:** Oregon Iron Works Clackamas, Or.**Location:** Clackamas, OR**CWI Name:** Mike Gregson, Rob Walters**CWI Present:** Yes No**Inspected CWI report:** Yes No N/A**Rod Oven in Use:** Yes No N/A**Electrode to specification:** Yes No N/A**Weld Procedures Followed:** Yes No N/A**Qualified Welders:** Yes No N/A**Verified Joint Fit-up:** Yes No N/A**Approved Drawings:** Yes No N/A**Approved WPS:** Yes No N/A**Delayed / Cancelled:** Yes No N/A**Bridge No:** 34-0006**Component:** Hinge K Pipe Beams**Summary of Items Observed:**

## OIW Fabrication Shop-Bay 3

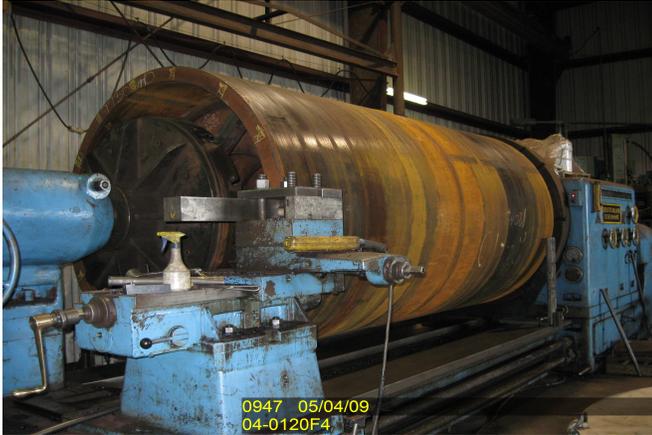
After arriving at A&G Machining, QA Inspector noticed the assembly 120A-3 had been previously set-up in the horizontal lathe by A&G machinist, in preparation for rough machining, but OIW project manager Bill Pender and OIW machinist were not present to verify random outside diameter roundness checks. A&G machinist explained to QA Inspector that project manager Bill Pender had called A&G, approximately ten minutes prior to QA Inspector arriving and cancelled the 10:00 A.M. appointment, on this date. A&G machinist explained to QA Inspector that Mr. Bill Pender and OIW machinist would be arriving on the following day, 5/05/09. See assembly 120A-3 set up in horizontal lathe, in attached picture below.....

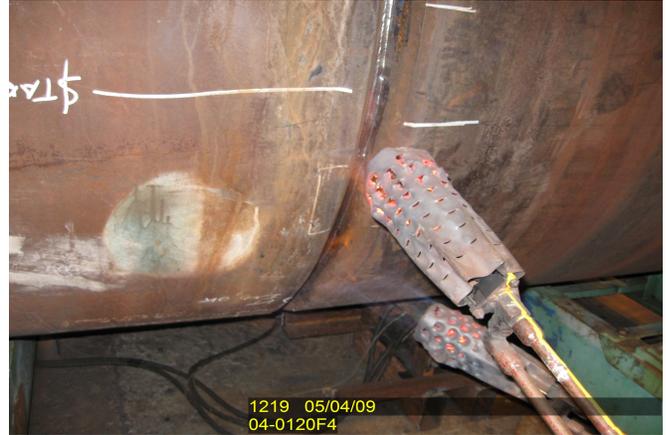
QA Inspector verified Mr. Jerry Shepherd was currently qualified for this welding process/position and performed a random pre-heat check and recorded temperatures of approximately 350 degrees Fahrenheit. QA Inspector also recorded random, in-process welding parameters (amps/volts) of 580 amps and 29 volts, which is in compliance with the OIW welding procedure specification (WPS 4020). See pre-heating pictures attached below.....
