Contract #: 04-0120F4Cty: SF/ALA Rte: 80 PM: 13.2/13.9File #: 69.28**WELDING INSPECTION REPORT****Resident Engineer:** Pursell, Gary**Address:** 333 Burma Road**City:** Oakland, CA 94607**Report No:** WIR-006652**Date Inspected:** 06-May-2009**Project Name:** SAS Superstructure**OSM Arrival Time:** 700**Prime Contractor:** American Bridge/Fluor Enterprises, a JV**OSM Departure Time:** 1900**Contractor:** Zhenhua Port Machinery Company, Ltd (ZPMC), Changxing Island **Location:** Shanghai, China**CWI Name:** Chen Xi**CWI Present:** Yes No**Inspected CWI report:** Yes No N/A**Rod Oven in Use:** Yes No N/A**Electrode to specification:** Yes No N/A**Weld Procedures Followed:** Yes No N/A**Qualified Welders:** Yes No N/A**Verified Joint Fit-up:** Yes No N/A**Approved Drawings:** Yes No N/A**Approved WPS:** Yes No N/A**Delayed / Cancelled:** Yes No N/A**Bridge No:** 34-0006**Component:** OBG crossbeams**Summary of Items Observed:**

OBG cross beam CB1

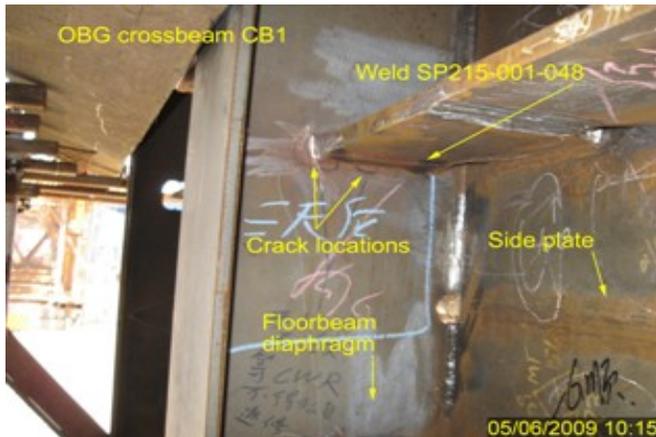
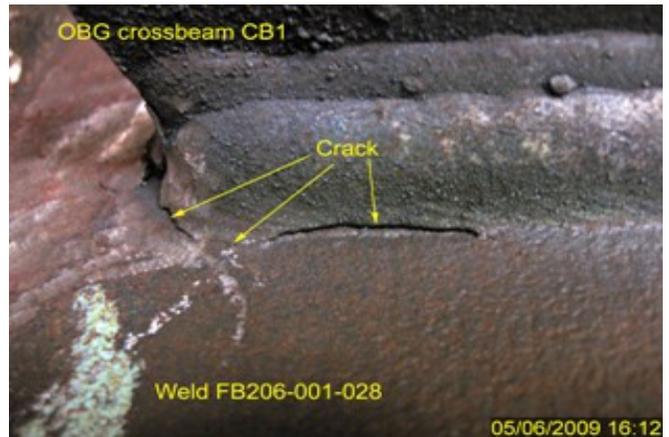
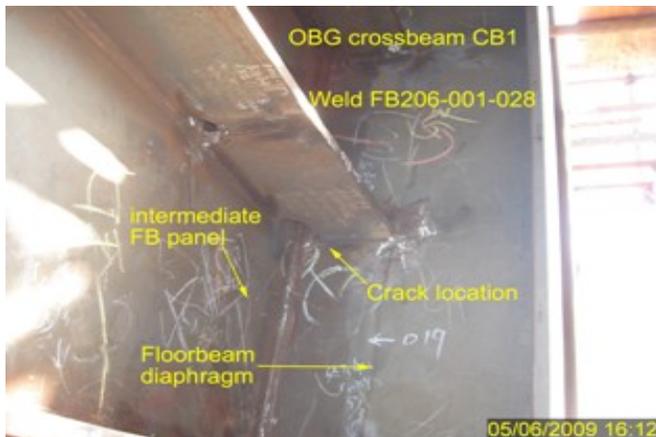
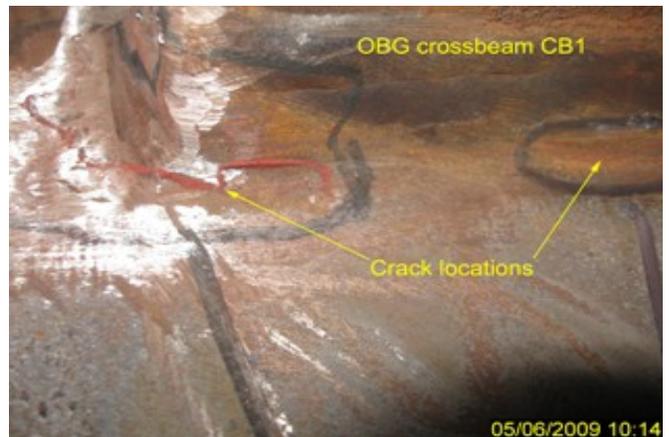
During random Visual Testing (VT) this QA observed two cracks in two Complete Joint Penetration (CJP) welds identified as SB215-001-048 and FB206-001-028. Weld SB215-001-048 is joining one of the west side panel stiffener ends to the floorbeam diaphragm nearest to the south end of the crossbeam. Weld FB206-001-028 is joining one of the intermediate panel stiffener ends to the floorbeam diaphragm nearest to the north end of the crossbeam. This QA informed The contractors Quality Control (QC) Certified Welding Inspector (CWI) identified as Mr. Chen Xi as well as American Bridge Fluor (ABF) lead inspector identified as Mr. Kelvin Cheung of this issue. Mr. Cheung informed this QA that he instructed the contractors personnel to grind the cracked areas in order to determine the extent of the cracks. At this time this QA does not know exactly what the contractor intends to do to repair these cracks. This QA has informed the contractors QA identified as Mr. Wang Lu and ABF representative identified as Mr. Noe Pasiola that an incident report would be submitted for this issue.
