DEPARTMENT OF TRANSPORTATION

Contract #: 04-0120F4Cty: SF/ALA Rte: 80 PM: 13.2/13.9File #: 13.28**WELDING INSPECTION REPORT****Resident Engineer:** Pursell, Gary**Address:** 333 Burma Road**City:** Oakland, CA 94607**Report No:** WIR-006682**Date Inspected:** 11-May-2009**Project Name:** SAS Superstructure**OSM Arrival Time:** 700**Prime Contractor:** American Bridge/Fluor Enterprises, a JV**OSM Departure Time:** 1530**Contractor:** Oregon Iron Works Clackamas, Or.**Location:** Clackamas, OR**CWI Name:** Mike Gregson, Rob Walters**CWI Present:** Yes No**Inspected CWI report:** Yes No N/A**Rod Oven in Use:** Yes No N/A**Electrode to specification:** Yes No N/A**Weld Procedures Followed:** Yes No N/A**Qualified Welders:** Yes No N/A**Verified Joint Fit-up:** Yes No N/A**Approved Drawings:** Yes No N/A**Approved WPS:** Yes No N/A**Delayed / Cancelled:** Yes No N/A**Bridge No:** 34-0006**Component:** Hinge K Pipe Beams**Summary of Items Observed:**

WELDING INSPECTION REPORT

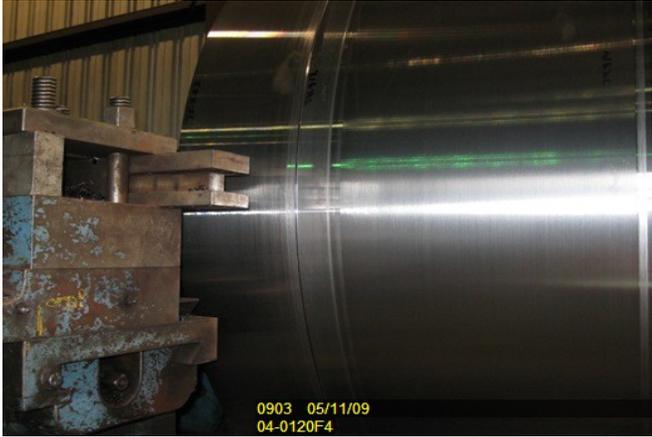
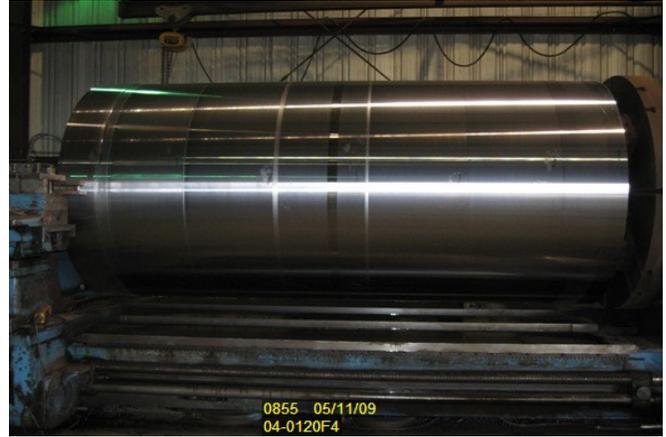
QA Inspector arrived at A&G Machining and noticed the fuse assembly 120A-3 rough machining was completed on this date and A&G machinist had measured outside diameter at seven random locations, as shown below.

QA Inspector noted that A&G appeared to be in compliance with the contract requirements requiring a final rough machining outside diameter of 1900mm, with a tolerance of (+/- 3mm).

Accuardi would be arriving the following day on 5/12/09 to verify these readings and transport this assembly 120A-3 back to OIW fabrication shop, for 100% magnetic particle testing, on the exterior machined surface. See attached picture below of rough machined fuse assembly 120A-3.
