DEPARTMENT OF TRANSPORTATION

Contract #: 04-0120F4Cty: SF/ALA Rte: 80 PM: 13.2/13.9File #: 69.28**WELDING INSPECTION REPORT****Resident Engineer:** Pursell, Gary**Address:** 333 Burma Road**City:** Oakland, CA 94607**Report No:** WIR-006686**Date Inspected:** 11-May-2009**Project Name:** SAS Superstructure**OSM Arrival Time:** 700**Prime Contractor:** American Bridge/Fluor Enterprises, a JV**OSM Departure Time:** 1900**Contractor:** Zhenhua Port Machinery Company, Ltd (ZPMC), Changxing Island **Location:** Shanghai, China**CWI Name:** Chen Xi**CWI Present:** Yes No**Inspected CWI report:** Yes No N/A**Rod Oven in Use:** Yes No N/A**Electrode to specification:** Yes No N/A**Weld Procedures Followed:** Yes No N/A**Qualified Welders:** Yes No N/A**Verified Joint Fit-up:** Yes No N/A**Approved Drawings:** Yes No N/A**Approved WPS:** Yes No N/A**Delayed / Cancelled:** Yes No N/A**Bridge No:** 34-0006**Component:** OBG crossbeams**Summary of Items Observed:**

WELDING INSPECTION REPORT

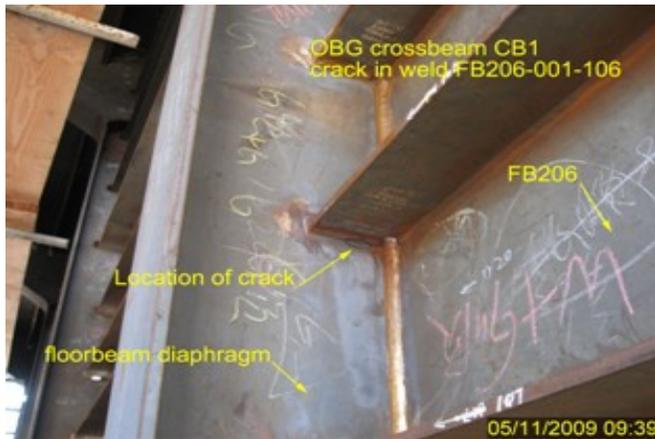
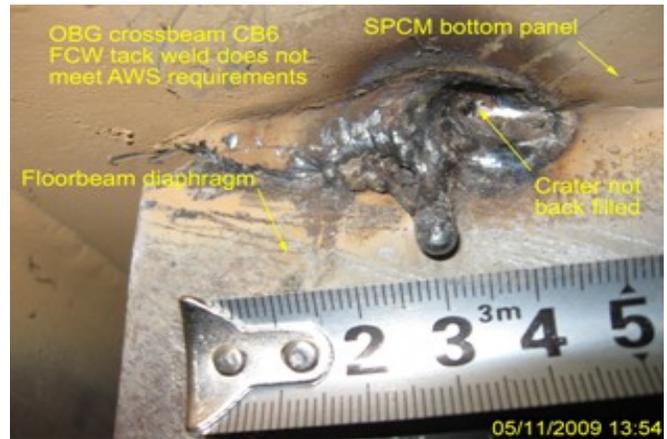
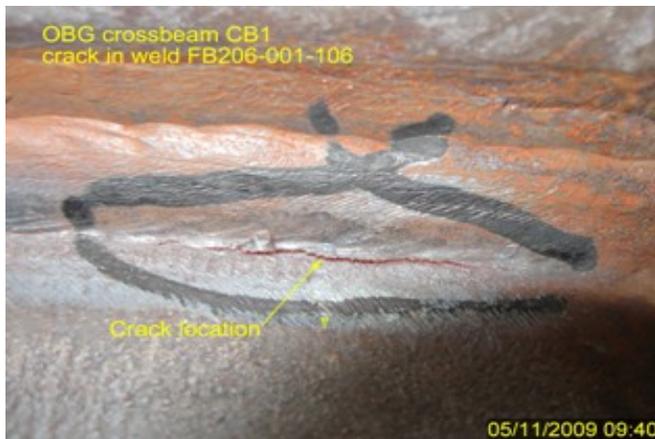
During random Visual Testing (VT) on the above mentioned crossbeam, this QA discovered another cracked Complete Joint Penetration (CJP) weld. The weld is identified as FB206-001-106. ZPMC QC CWI identified as Mr. Chen Xi concurred with this QA and instructed ZPMC personnel to grind the area in order to determine the extent of the crack. After grinding, ZPMC Magnetic particle Testing (MT) technician performed MT of the ground area and determined the area to be free from any discontinuities. The grinding did not reduce the size of the weld beyond the size tolerance specified in AWS D1.5 2002. No repair welding was required.

During random Visual Testing (VT) of the tack welds on the above mentioned crossbeam this QA found numerous Fracture Critical Weld (FCW) tack welds that did not appear to meet the requirements of AWS D1.5 2002 section 12. The tack welds are located at the fillet weld joint joining the floorbeam diaphragms to the SPCM bottom panel. The tack welds exhibited a number of non-compliant discontinuities including undercut, overlap and the tack welds not meeting the minimum required length of 75mm as per AWS D1.5 2002 table 12.2. This QA informed representatives from both ZPMC QC and ABF QC that an incident report would be issued for this issue.
