DEPARTMENT OF TRANSPORTATION

Quality Assurance and Source Inspection

Contract #: 04-0120F4Cty: SF/ALA Rte: 80 PM: 13.2/13.9File #: 13.28**WELDING INSPECTION REPORT****Resident Engineer:** Pursell, Gary**Address:** 333 Burma Road**City:** Oakland, CA 94607**Report No:** WIR-006700**Date Inspected:** 12-May-2009**Project Name:** SAS Superstructure**OSM Arrival Time:** 700**Prime Contractor:** American Bridge/Fluor Enterprises, a JV**OSM Departure Time:** 1530**Contractor:** Oregon Iron Works Clackamas, Or.**Location:** Clackamas, OR**CWI Name:** Mike Gregson, Rob Walters**CWI Present:** Yes No**Inspected CWI report:** Yes No N/A**Rod Oven in Use:** Yes No N/A**Electrode to specification:** Yes No N/A**Weld Procedures Followed:** Yes No N/A**Qualified Welders:** Yes No N/A**Verified Joint Fit-up:** Yes No N/A**Approved Drawings:** Yes No N/A**Approved WPS:** Yes No N/A**Delayed / Cancelled:** Yes No N/A**Bridge No:** 34-0006**Component:** Hinge K Pipe Beams**Summary of Items Observed:**

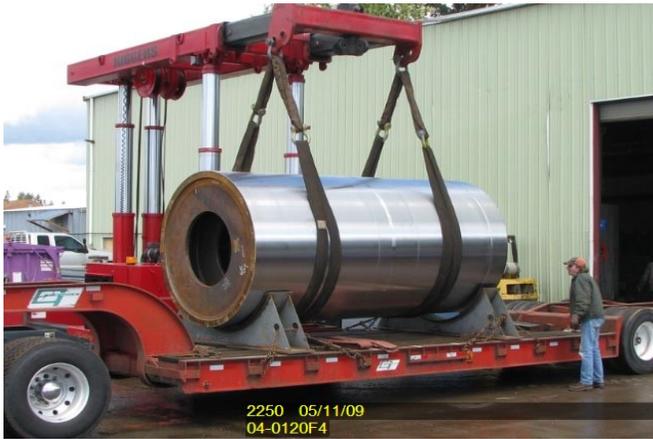
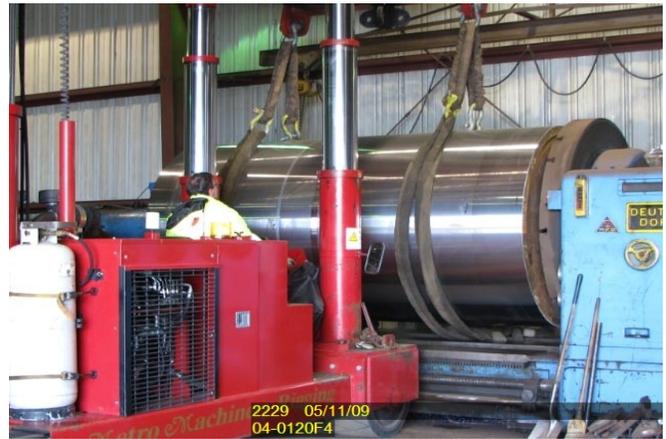
Lead QA Inspector Joe Adame explained that he had spoken with A&G and A&G explained that the rough machining on the exterior of fuse assembly 120A-3 was complete and was in-process of being transferred back to OIW fabrication shop for 100% magnetic particle testing on the exterior machined surface. See A&G pictures below of fuse assembly being loaded on a trailer.
