DEPARTMENT OF TRANSPORTATION

Contract #: 04-0120F4Cty: SF/ALA Rte: 80 PM: 13.2/13.9File #: 69.28**WELDING INSPECTION REPORT****Resident Engineer:** Pursell, Gary**Address:** 333 Burma Road**City:** Oakland, CA 94607**Report No:** WIR-006838**Date Inspected:** 25-May-2009**Project Name:** SAS Superstructure**OSM Arrival Time:** 700**Prime Contractor:** American Bridge/Fluor Enterprises, a JV**OSM Departure Time:** 1900**Contractor:** Zhenhua Port Machinery Company, Ltd (ZPMC), Changxing Island **Location:** Shanghai, China**CWI Name:** Wu Zhi Cheng**CWI Present:** Yes No**Inspected CWI report:** Yes No N/A**Rod Oven in Use:** Yes No N/A**Electrode to specification:** Yes No N/A**Weld Procedures Followed:** Yes No N/A**Qualified Welders:** Yes No N/A**Verified Joint Fit-up:** Yes No N/A**Approved Drawings:** Yes No N/A**Approved WPS:** Yes No N/A**Delayed / Cancelled:** Yes No N/A**Bridge No:** 34-0006**Component:** Superstructure trial assembly**Summary of Items Observed:**

OBG superstructure trial assembly east line

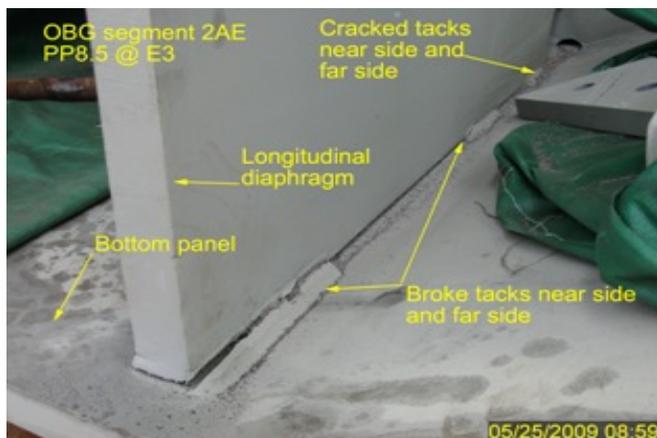
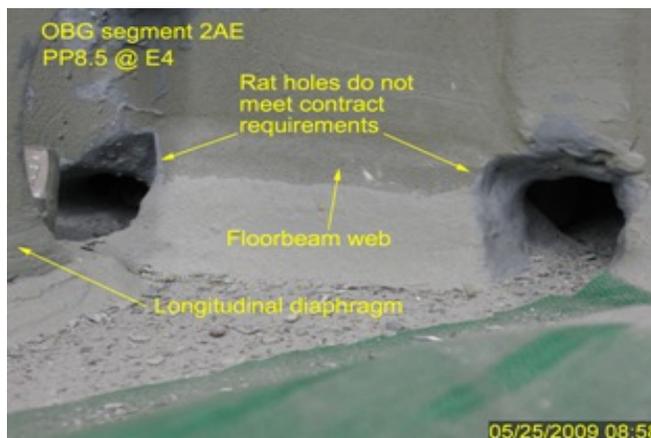
During random in process visual inspection of OBG segment 2AE, this QA observed 6 cracked tack welds. The tack welds in question are joining the longitudinal diaphragm to the bottom panel near panel point 8.5 at E3. The longitudinal diaphragm is identified as LD26A and the bottom panel is identified as BP312A. This is non compliant to AWS D1.5 2002 section 3, paragraph 3.3.7.1 which states "tack welds shall be subject to the same quality requirements as the finished welds" and 6.26.1.1 which states "The weld shall have no cracks". (See attached photos).

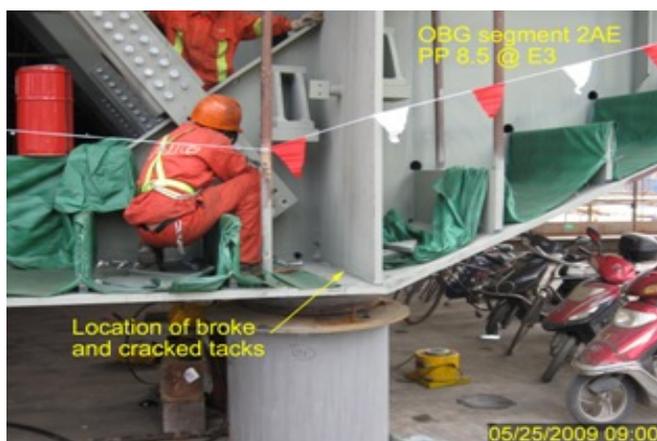
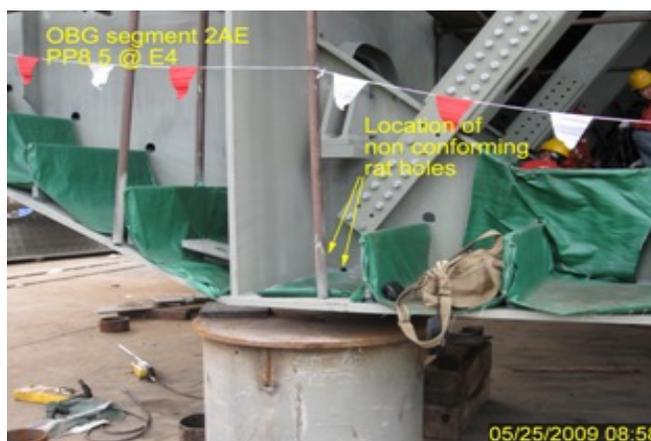
This QA observed cope holes in floorbeams FB66A, FB72A, FB88A and FB89A that do not appear to comply with the contract documents. These cope holes are located on OBG segment 2AE at or near the intersection of panel point 8.5 and E4 and at the intersection of panel point 9 and E3 where the floorbeam web is welded to the side and bottom panels. They appear to be non compliant to shop detail drawing numbers FB66, FB72, FB88 and FB89 which specify that the cope holes are to have a 25mm radius. AWS D1.5 2002 section 3.2.5 states "Radii of beam copes and weld access holes shall provide a smooth transition, free of notches or cutting past the points of tangency between adjacent surfaces". (See attached photos).
