DEPARTMENT OF TRANSPORTATION

Contract #: 04-0120F4Cty: SF/ALA Rte: 80 PM: 13.2/13.9File #: 74.28**WELDING INSPECTION REPORT****Resident Engineer:** Pursell, Gary**Address:** 333 Burma Road**City:** Oakland, CA 94607**Report No:** WIR-006991**Date Inspected:** 27-May-2009**Project Name:** SAS Superstructure**OSM Arrival Time:** 800**Prime Contractor:** American Bridge/Fluor Enterprises, a JV**OSM Departure Time:** 1800**Contractor:** Goodwin Steel, UK**Location:** Stoke-on-Trent, UK

CWI Name:	n/a	CWI Present:	Yes	No
Inspected CWI report:	Yes No N/A	Rod Oven in Use:	Yes No N/A	
Electrode to specification:	Yes No N/A	Weld Procedures Followed:	Yes No N/A	
Qualified Welders:	Yes No N/A	Verified Joint Fit-up:	Yes No N/A	
Approved Drawings:	Yes No N/A	Approved WPS:	Yes No N/A	
		Delayed / Cancelled:	Yes No N/A	
Bridge No:	34-0006	Component:	Cable Band

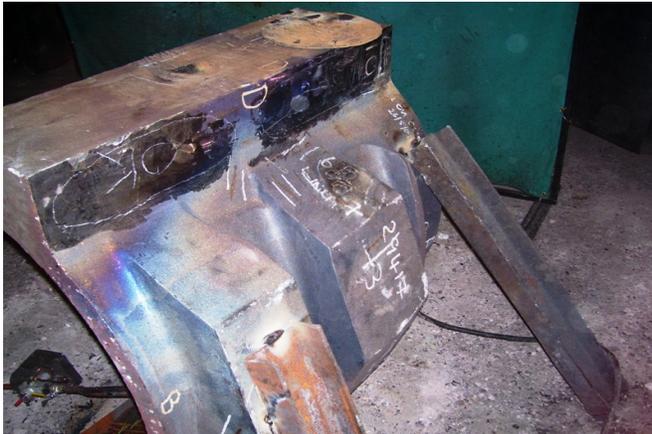
Item	Description	WBS	Dwg No.	Status
1	Temporary attachment

Observed repair welding of Casting B1-1-F G29417-3. The welding was being completed by Adrian Barnett. The welder qualification records for Mr. Barnett were reviewed and are in compliance with ASME Code Section IX and contract special provisions. Mr. Barnett was observed welding a temporary attachment to the casting in an area that will not be machined. A photograph is attached. This was reported to Les Peake, Quality Control Manager. The Amp Meter on the welding power supply was observed to be operating outside of the limits of the Welding Procedure Specification. The Amperage was verified with a Fluke Clamp Meter (serial number 98290166 cal due 4/8/10) and was noted to be 125 Amps which is within the parameters of the WPS for the 4mm electrode being used in making the SMAW weld. This was reported to the welding supervisor Mr. Terry Knall. The company providing calibration services has been contacted and is scheduled to recalibrate all of the welding power supplies this week.
