Contract #: 04-0120F4Cty: SF/ALA Rte: 80 PM: 13.2/13.9File #: 13.28**WELDING INSPECTION REPORT****Resident Engineer:** Pursell, Gary**Address:** 333 Burma Road**City:** Oakland, CA 94607**Report No:** WIR-007007**Date Inspected:** 29-May-2009**Project Name:** SAS Superstructure**OSM Arrival Time:** 1400**Prime Contractor:** American Bridge/Fluor Enterprises, a JV**OSM Departure Time:** 2350**Contractor:** Oregon Iron Works Clackamas, Or.**Location:** Clackamas, Oregon**CWI Name:** Steve Barnett**CWI Present:** Yes No**Inspected CWI report:** Yes No N/A**Rod Oven in Use:** Yes No N/A**Electrode to specification:** Yes No N/A**Weld Procedures Followed:** Yes No N/A**Qualified Welders:** Yes No N/A**Verified Joint Fit-up:** Yes No N/A**Approved Drawings:** Yes No N/A**Approved WPS:** Yes No N/A**Delayed / Cancelled:** Yes No N/A**Bridge No:** 34-0006**Component:** Hinge K Pipe Beams**Summary of Items Observed:**

WELDING INSPECTION REPORT

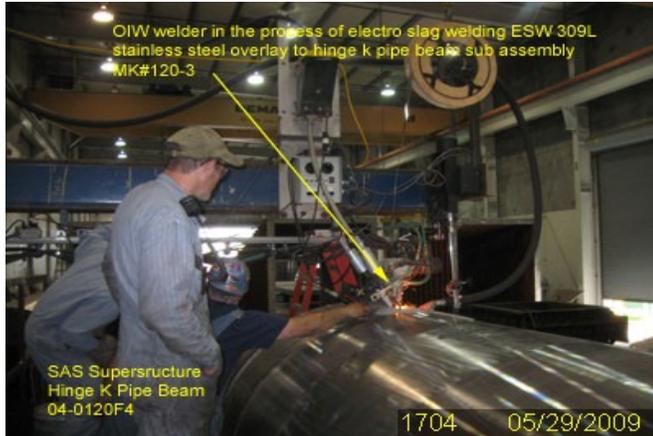
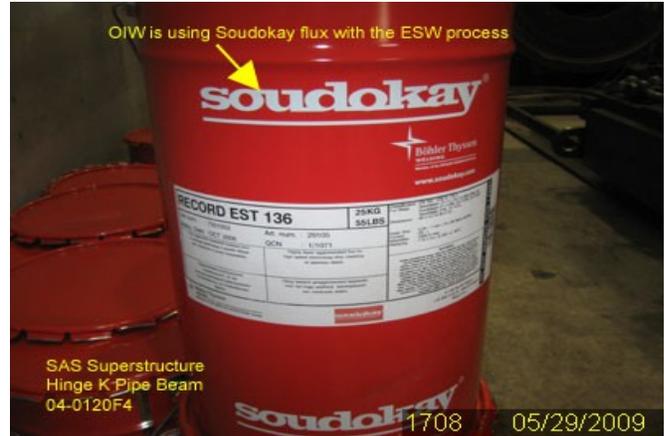
QA Inspector Brannon randomly observed OIW qualified welder Mr. Bounheune Savanh ID#S74 and one helper welding soudotape 309L stainless steel overlay to hinge k pipe beam fuse sub-assembly 120A-3. The weld joint is identified as 309L 1st layer. Mr. Savanh was observed welding in the flat position utilizing automatic electro slag welding (ESW) overlay process with a .5mm x 60mm soudotape 309L stainless electrode, filler metal brand Soudotape class EQ309L automatic. QA Inspector Brannon observed the OIW QC CWI Inspector Mr. Steve Barnett verifying that the pre-heat of 225°F and welding parameters were in accordance with the Welding Procedure Specification (WPS). Welding parameters observed by QA Inspector Brannon are as follows: 1160 amps, 24.1 volts and a travel speed of 255mm per minute appear to be in conformance with approved welding procedure specification (WPS 7003) revision number 0.

The following digital photograph below illustrates observation of the activities being performed.
