**DEPARTMENT OF TRANSPORTATION**

Contract #: 04-0120F4Cty: SF/ALA Rte: 80 PM: 13.2/13.9File #: 73.28**WELDING INSPECTION REPORT****Resident Engineer:** Pursell, Gary**Address:** 333 Burma Road**City:** Oakland, CA 94607**Report No:** WIR-007152**Date Inspected:** 05-Jun-2009**Project Name:** SAS Superstructure**OSM Arrival Time:** 800**Prime Contractor:** American Bridge/Fluor Enterprises, a JV**OSM Departure Time:** 1800**Contractor:** HoChang, Korea**Location:** Unyang/Changwon, Korea

**Bridge No:** 34-0006**Component:** Pier E2 Bearing and Shear Key**Summary of Items Observed:**

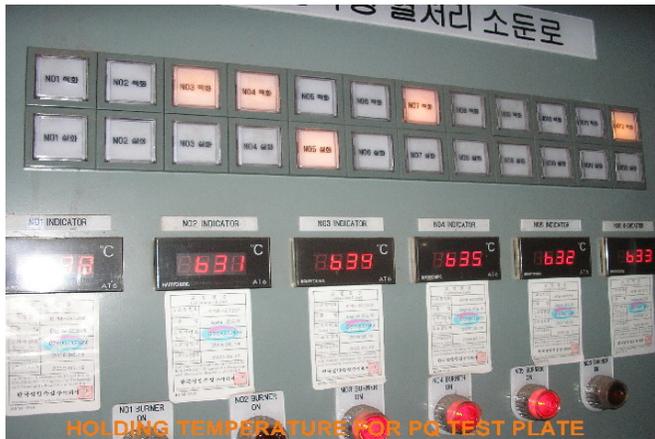
This QA inspector observed Post Weld Heat Treatment (PWHT) was in progress on a Procedure Qualification

Record (PQR). Please see photo below of PWHT holding temperature.
