**DEPARTMENT OF TRANSPORTATION**

Contract #: 04-0120F4Cty: SF/ALA Rte: 80 PM: 13.2/13.9File #: 13.28**WELDING INSPECTION REPORT****Resident Engineer:** Pursell, Gary**Address:** 333 Burma Road**City:** Oakland, CA 94607**Report No:** WIR-007248**Date Inspected:** 15-Jun-2009**Project Name:** SAS Superstructure**OSM Arrival Time:** 700**Prime Contractor:** American Bridge/Fluor Enterprises, a JV**OSM Departure Time:** 1530**Contractor:** Oregon Iron Works Clackamas, Or.**Location:** Clackamas, OR**CWI Name:** Mike Gregson, Rob Walters**CWI Present:** Yes No**Inspected CWI report:** Yes No N/A**Rod Oven in Use:** Yes No N/A**Electrode to specification:** Yes No N/A**Weld Procedures Followed:** Yes No N/A**Qualified Welders:** Yes No N/A**Verified Joint Fit-up:** Yes No N/A**Approved Drawings:** Yes No N/A**Approved WPS:** Yes No N/A**Delayed / Cancelled:** Yes No N/A**Bridge No:** 34-0006**Component:** Hinge K Pipe Beams**Summary of Items Observed:**

## WELDING INSPECTION REPORT

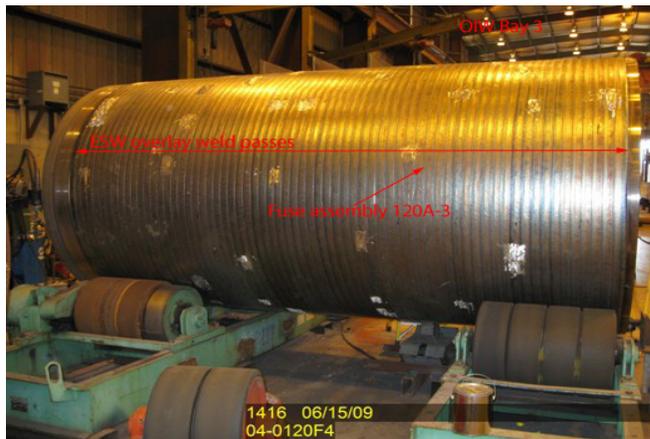
QA Inspector noticed that the stainless steel overlay welding was complete on this fuse assembly 120A-3 and was sitting idle. QA Inspector noted that a total of three ESW passes were utilized using OIW approved welding procedure specification (WPS 7003) and various welding terminations (start/stops) were blended utilizing a grinder. QA Inspector noted that the final outside dimensional measurements were measured at 12 ½" (152mm) increments and an average diameter of 1927.45mm was recorded, which appears to be in compliance with the applicable contract requirements. See attached picture of completed ESW fuse assembly 120A-3 below.
