DEPARTMENT OF TRANSPORTATION

Contract #: 04-0120F4Cty: SF/ALA Rte: 80 PM: 13.2/13.9File #: 69.28**WELDING INSPECTION REPORT****Resident Engineer:** Pursell, Gary**Address:** 333 Burma Road**City:** Oakland, CA 94607**Report No:** WIR-007274**Date Inspected:** 10-Jun-2009**Project Name:** SAS Superstructure**OSM Arrival Time:** 700**Prime Contractor:** American Bridge/Fluor Enterprises, a JV**OSM Departure Time:** 1900**Contractor:** Zhenhua Port Machinery Company, Ltd (ZPMC), Changxing Island **Location:** Shanghai, China**CWI Name:** Shi Lin**CWI Present:** Yes No**Inspected CWI report:** Yes No N/A**Rod Oven in Use:** Yes No N/A**Electrode to specification:** Yes No N/A**Weld Procedures Followed:** Yes No N/A**Qualified Welders:** Yes No N/A**Verified Joint Fit-up:** Yes No N/A**Approved Drawings:** Yes No N/A**Approved WPS:** Yes No N/A**Delayed / Cancelled:** Yes No N/A**Bridge No:** 34-0006**Component:** trial assembly**Summary of Items Observed:**

OBG superstructure trial assembly east line

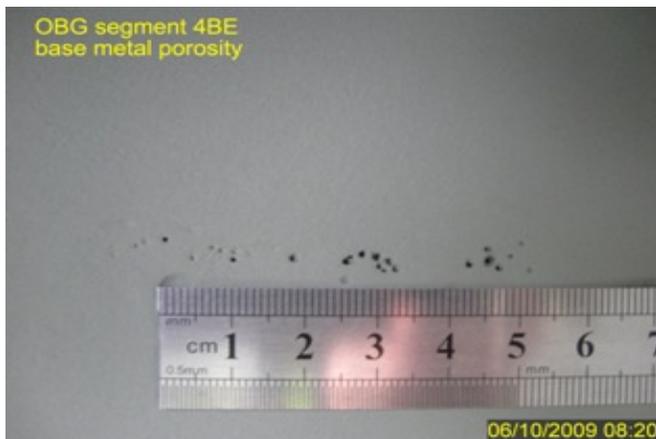
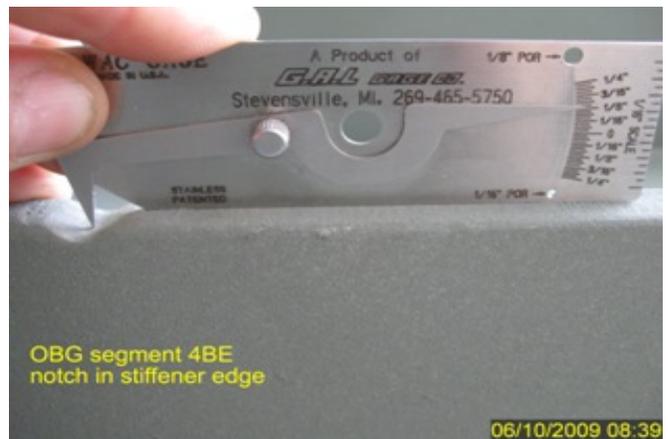
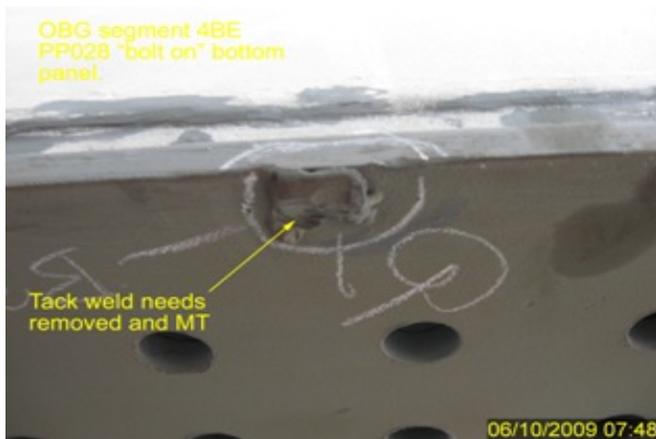
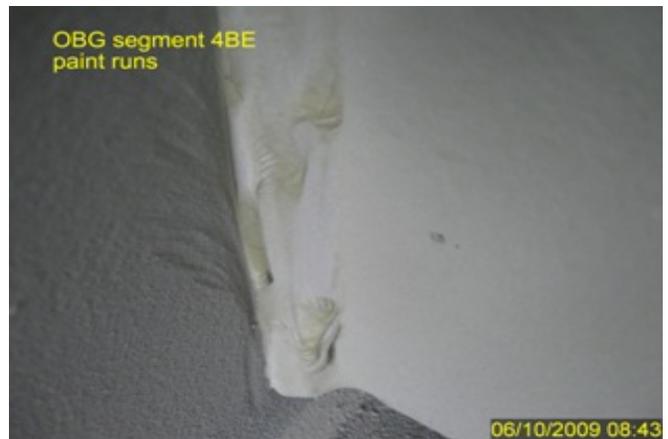
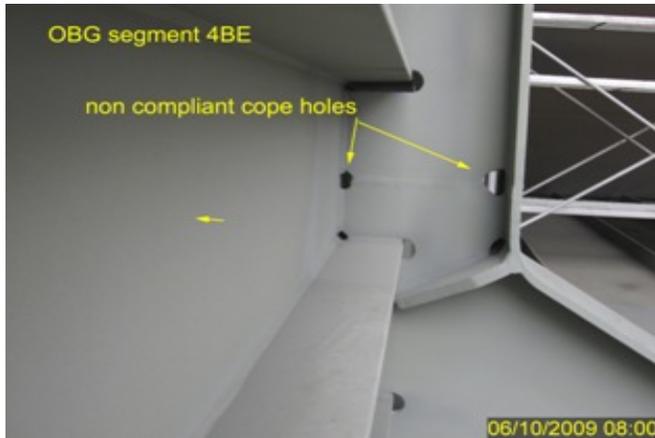
During random visual inspection of segment 4AE/4BE this QA observed the following: FL3 stiffeners PP026, 027 and 028; numerous notches in edges of stiffeners need to be addressed, FL3 area "bolt on" bottom panel @ PP028; large temporary tack needs to be removed and MT performed by the contractor, PP028 near partial height floorbeam diaphragm; base metal porosity at base metal or tack weld removal site, various locations; stiffener pass through slots improper radius, paint runs and sags and web splices on partial height diaphragms; cope holes improper radius. This QA previously compiled a list of most of the above mentioned items on 5/30/09 and submitted it to Caltrans QA task leaders and Caltrans Island Structural Materials Representative (ISMR). This QA noted that the contractor has blasted and painted the FL3 area prior to addressing and/or performing needed repairs. See attached photos.
