DEPARTMENT OF TRANSPORTATION

Contract #: 04-0120F4Cty: SF/ALA Rte: 80 PM: 13.2/13.9File #: 69.28**WELDING INSPECTION REPORT****Resident Engineer:** Pursell, Gary**Address:** 333 Burma Road**City:** Oakland, CA 94607**Report No:** WIR-007275**Date Inspected:** 08-Jun-2009**Project Name:** SAS Superstructure**OSM Arrival Time:** 700**Prime Contractor:** American Bridge/Fluor Enterprises, a JV**OSM Departure Time:** 1900**Contractor:** Zhenhua Port Machinery Company, Ltd (ZPMC), Changxing Island **Location:** Shanghai, China**CWI Name:** Chen Chih Chien**CWI Present:** Yes No**Inspected CWI report:** Yes No N/A**Rod Oven in Use:** Yes No N/A**Electrode to specification:** Yes No N/A**Weld Procedures Followed:** Yes No N/A**Qualified Welders:** Yes No N/A**Verified Joint Fit-up:** Yes No N/A**Approved Drawings:** Yes No N/A**Approved WPS:** Yes No N/A**Delayed / Cancelled:** Yes No N/A**Bridge No:** 34-0006**Component:** crossbeams and segment 5AE**Summary of Items Observed:**

OBG segment 5AE (Superstructure trial assembly)

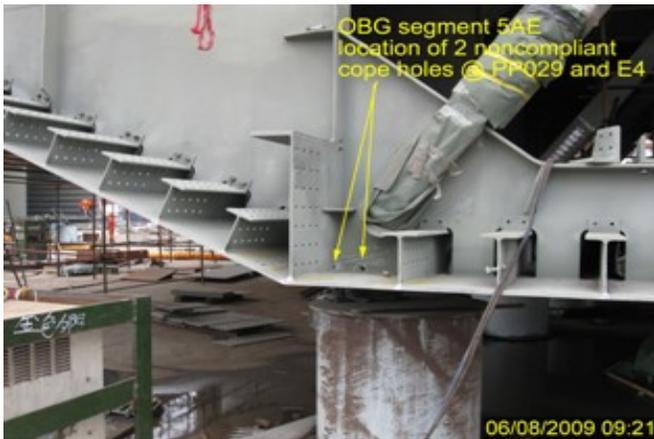
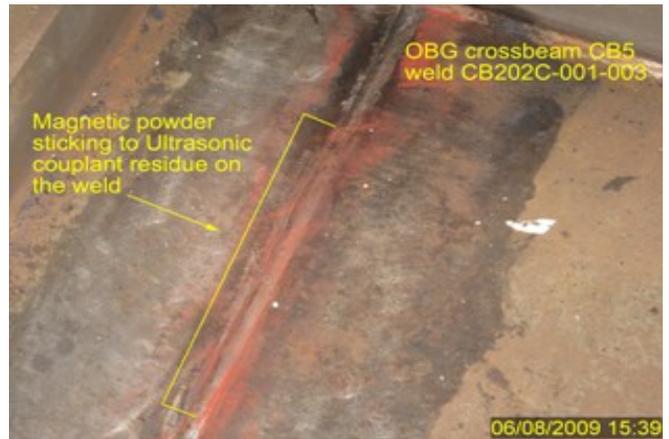
This QA observed cope holes in OBG segment floorbeams that do not appear to comply with the contract documents. These cope holes are located on OBG segment 5AE at or near the intersection of panel point 29 and E4 and at or near the intersection of panel point 29 and E3 where the floorbeam web is welded to the OBG side and bottom panels. (See attached photos for details). AWS D1.5 2002 section 3.2.5 states "Radii of beam copes and weld access holes shall provide a smooth transition, free of notches or cutting past the points of tangency between adjacent surfaces". This QA informed ZPMC QA identified as Mr. Wang Lu and ABF fabrication supervisor identified as Mr. Peter Ferguson that an incident report would be generated for this issue.
