Contract #: 04-0120F4Cty: SF/ALA Rte: 80 PM: 13.2/13.9File #: 69.28**WELDING INSPECTION REPORT****Resident Engineer:** Pursell, Gary**Address:** 333 Burma Road**City:** Oakland, CA 94607**Report No:** WIR-007279**Date Inspected:** 04-Jun-2009**Project Name:** SAS Superstructure**OSM Arrival Time:** 700**Prime Contractor:** American Bridge/Fluor Enterprises, a JV**OSM Departure Time:** 1700**Contractor:** Zhenhua Port Machinery Company, Ltd (ZPMC), Changxing Island **Location:** Shanghai, China**CWI Name:** Chen Chih Chien**CWI Present:** Yes No**Inspected CWI report:** Yes No N/A**Rod Oven in Use:** Yes No N/A**Electrode to specification:** Yes No N/A**Weld Procedures Followed:** Yes No N/A**Qualified Welders:** Yes No N/A**Verified Joint Fit-up:** Yes No N/A**Approved Drawings:** Yes No N/A**Approved WPS:** Yes No N/A**Delayed / Cancelled:** Yes No N/A**Bridge No:** 34-0006**Component:** OBG trial assembly**Summary of Items Observed:**

OBG cross beam CB3 (in superstructure trial assembly)

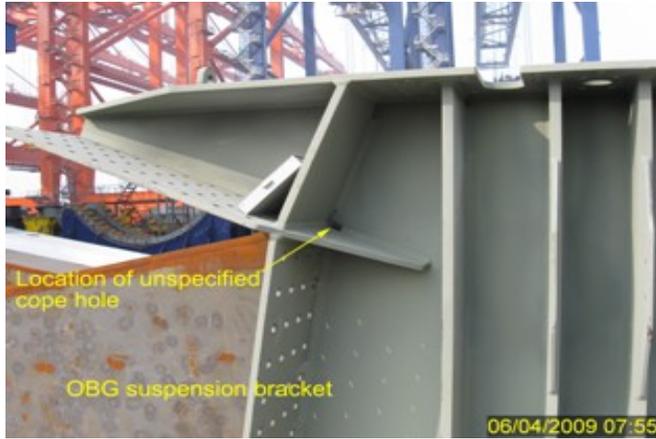
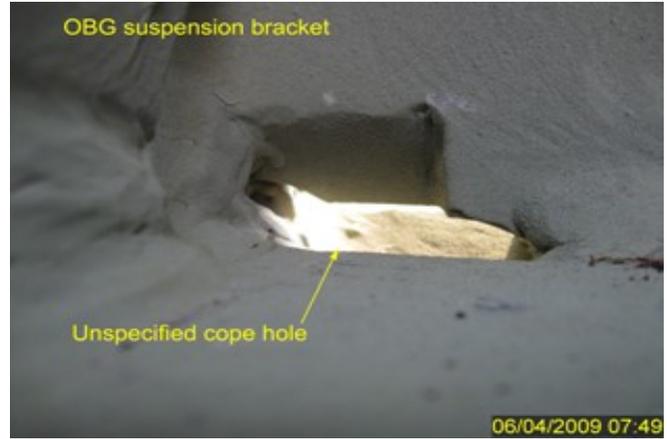
Suspension Brackets

During random visual inspection of the suspension brackets currently in the superstructure trial assembly this QA found that the contractor appears to have a small area of unfinished weld on each of the brackets. This QA informed ZPMC QA identified as Mr. Wang Lu of this discrepancy. Mr. Wang told this QA that he would look at the drawings to determine why these areas may have been left unwelded. As of the end of this shift this QA is still waiting for Mr. Wang to respond to this issue. See attached photos.
